REQUEST FOR PROPOSALS

8th Avenue over the South Branch of the Black River, Geneva Township (Structure #10769)

BRIDGE SAFETY INSPECTION REPORT			
STR 10769			
Facility	Latitude / Longitude	MDOT Structure ID	Structure Condition
8TH AVE	42.3893 / -86.2145	80309H00010B010	Poor Condition(4)
Feature	Length / Width / Spans	Owner	
S BR BLACK RIVER	53.8 / 29.5 / 3	County: Van Buren(80)	
Location	Built / Recon. / Paint / Ovly.	TSC	Operational Status
2.5 MI E OF SOUTH HAVEN	1967 / / /	Kalamazoo(16)	P Posted for load(314040)
Region / County	Material / Design	Last NBI Inspection	Scour Evaluation
Southwest(5) / Van Buren(80)	7 Wood or Timber / 01 Slab	04/24/2025 / PYS2	5 Stable w/in footing

Inspector Name	Agency / Company Name	Insp. Freq.	Insp. Date
Robert Lothschutz	Scott Civil Engineering Company	12	04/24/2025

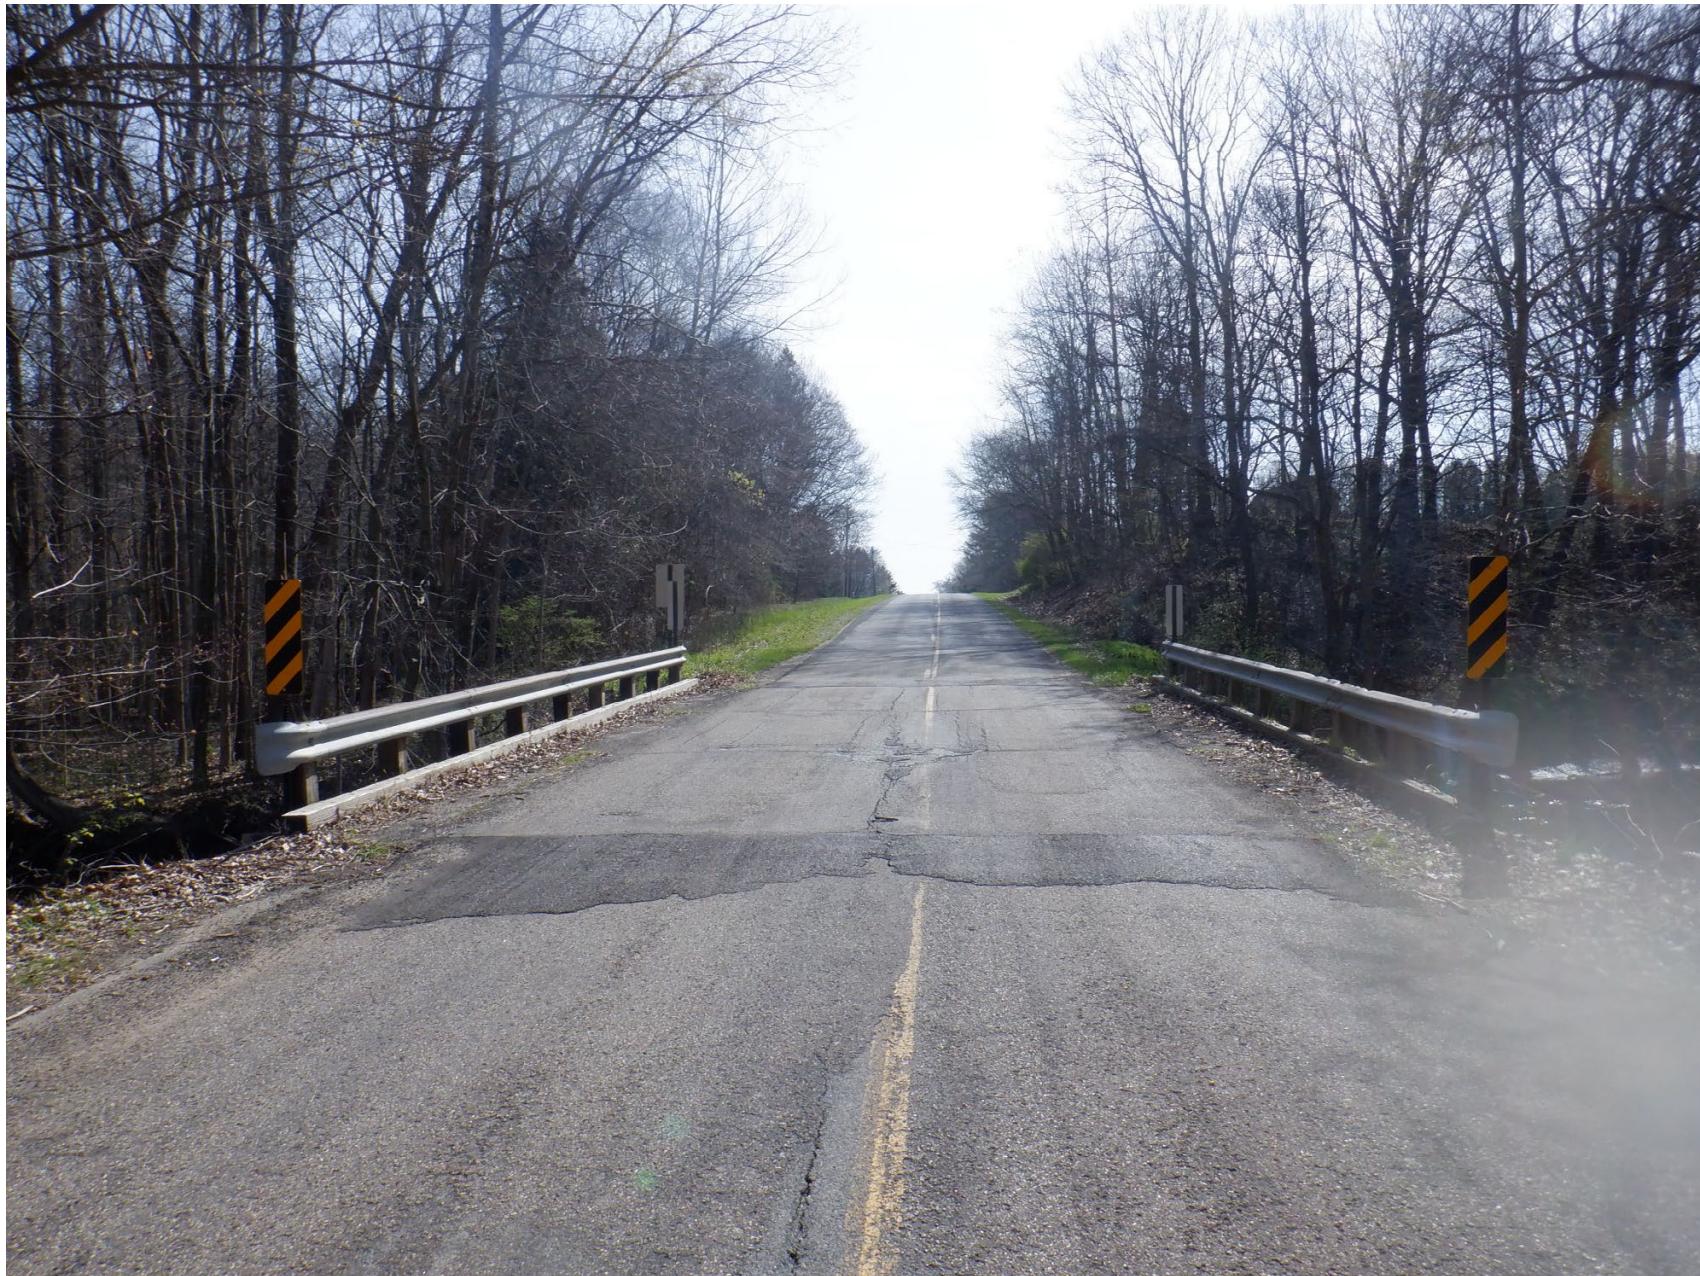
BRIDGE SECTION LOOKING EAST

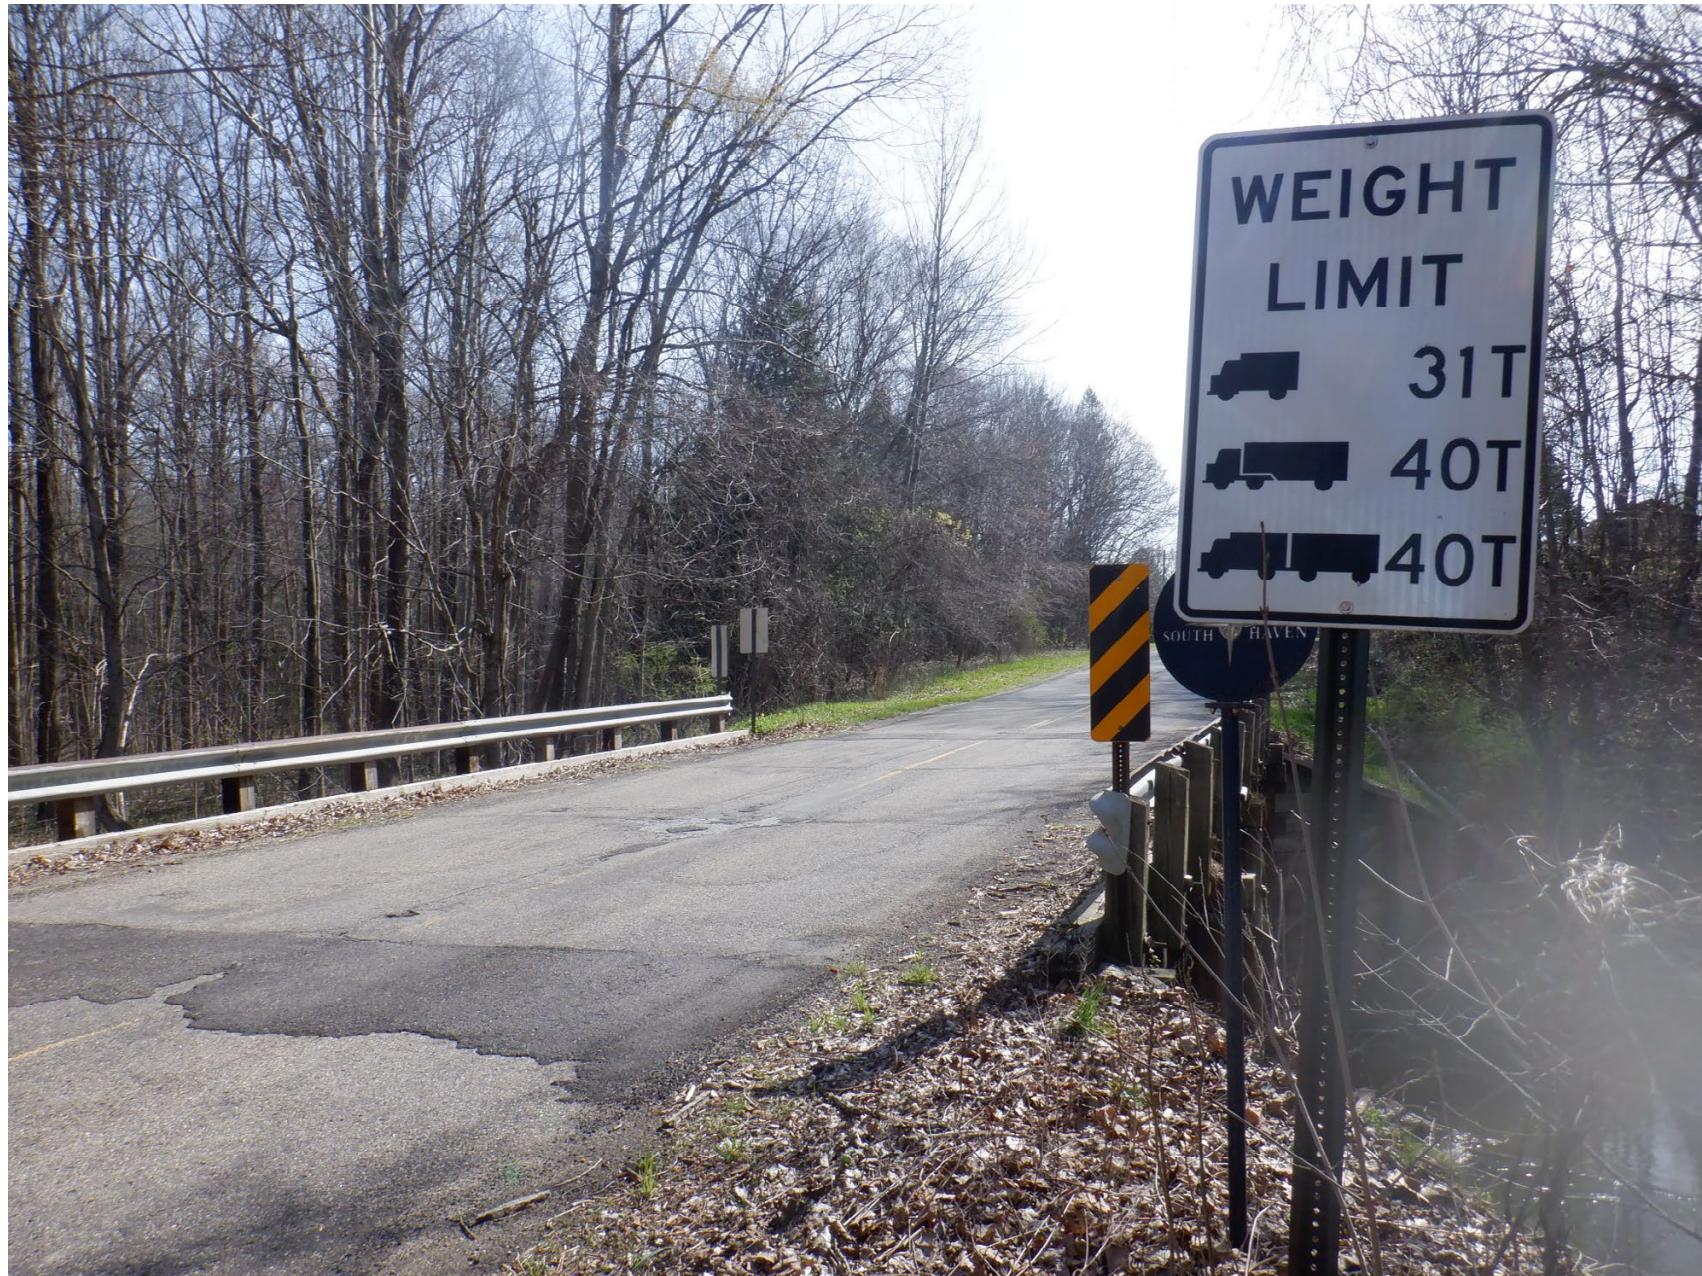
POSTING SIGN

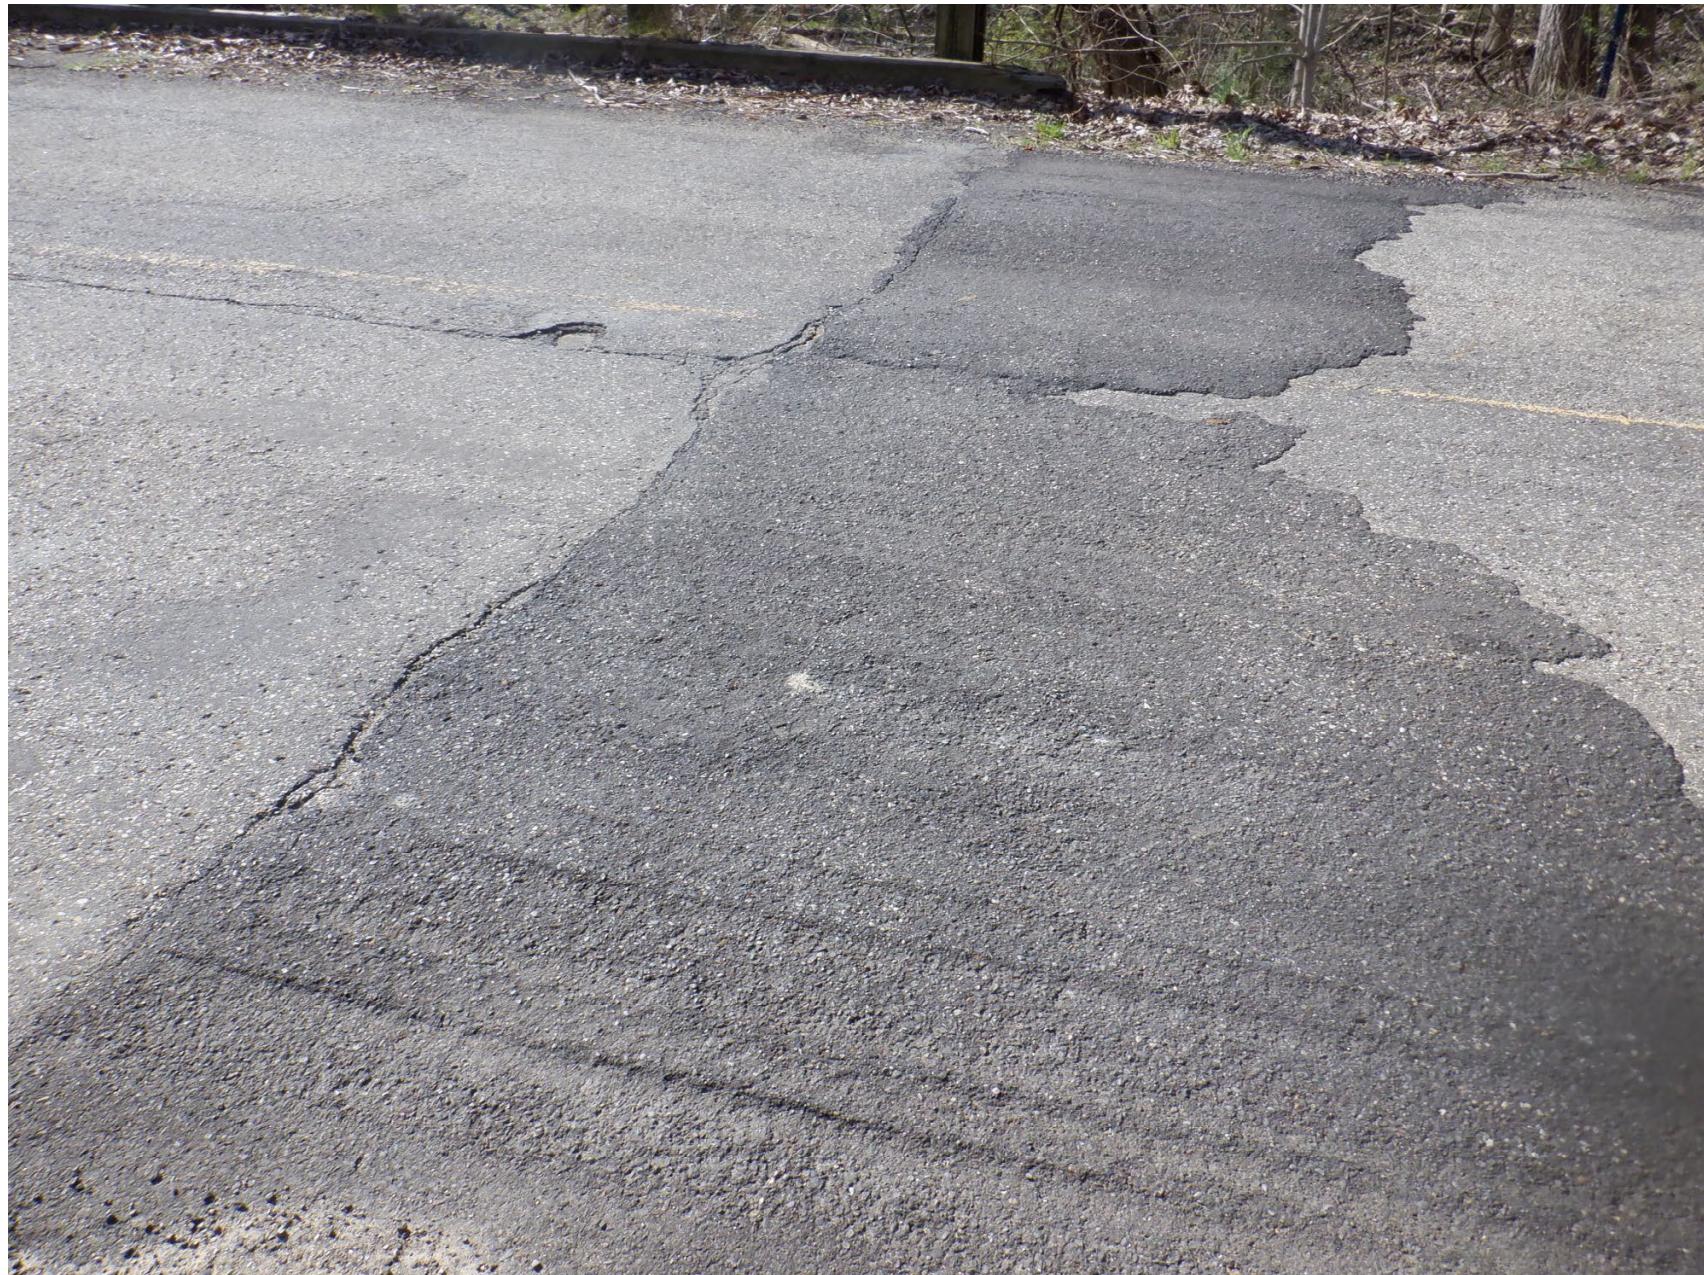
NEWER HMA WEDGING ON WEST APPROACH

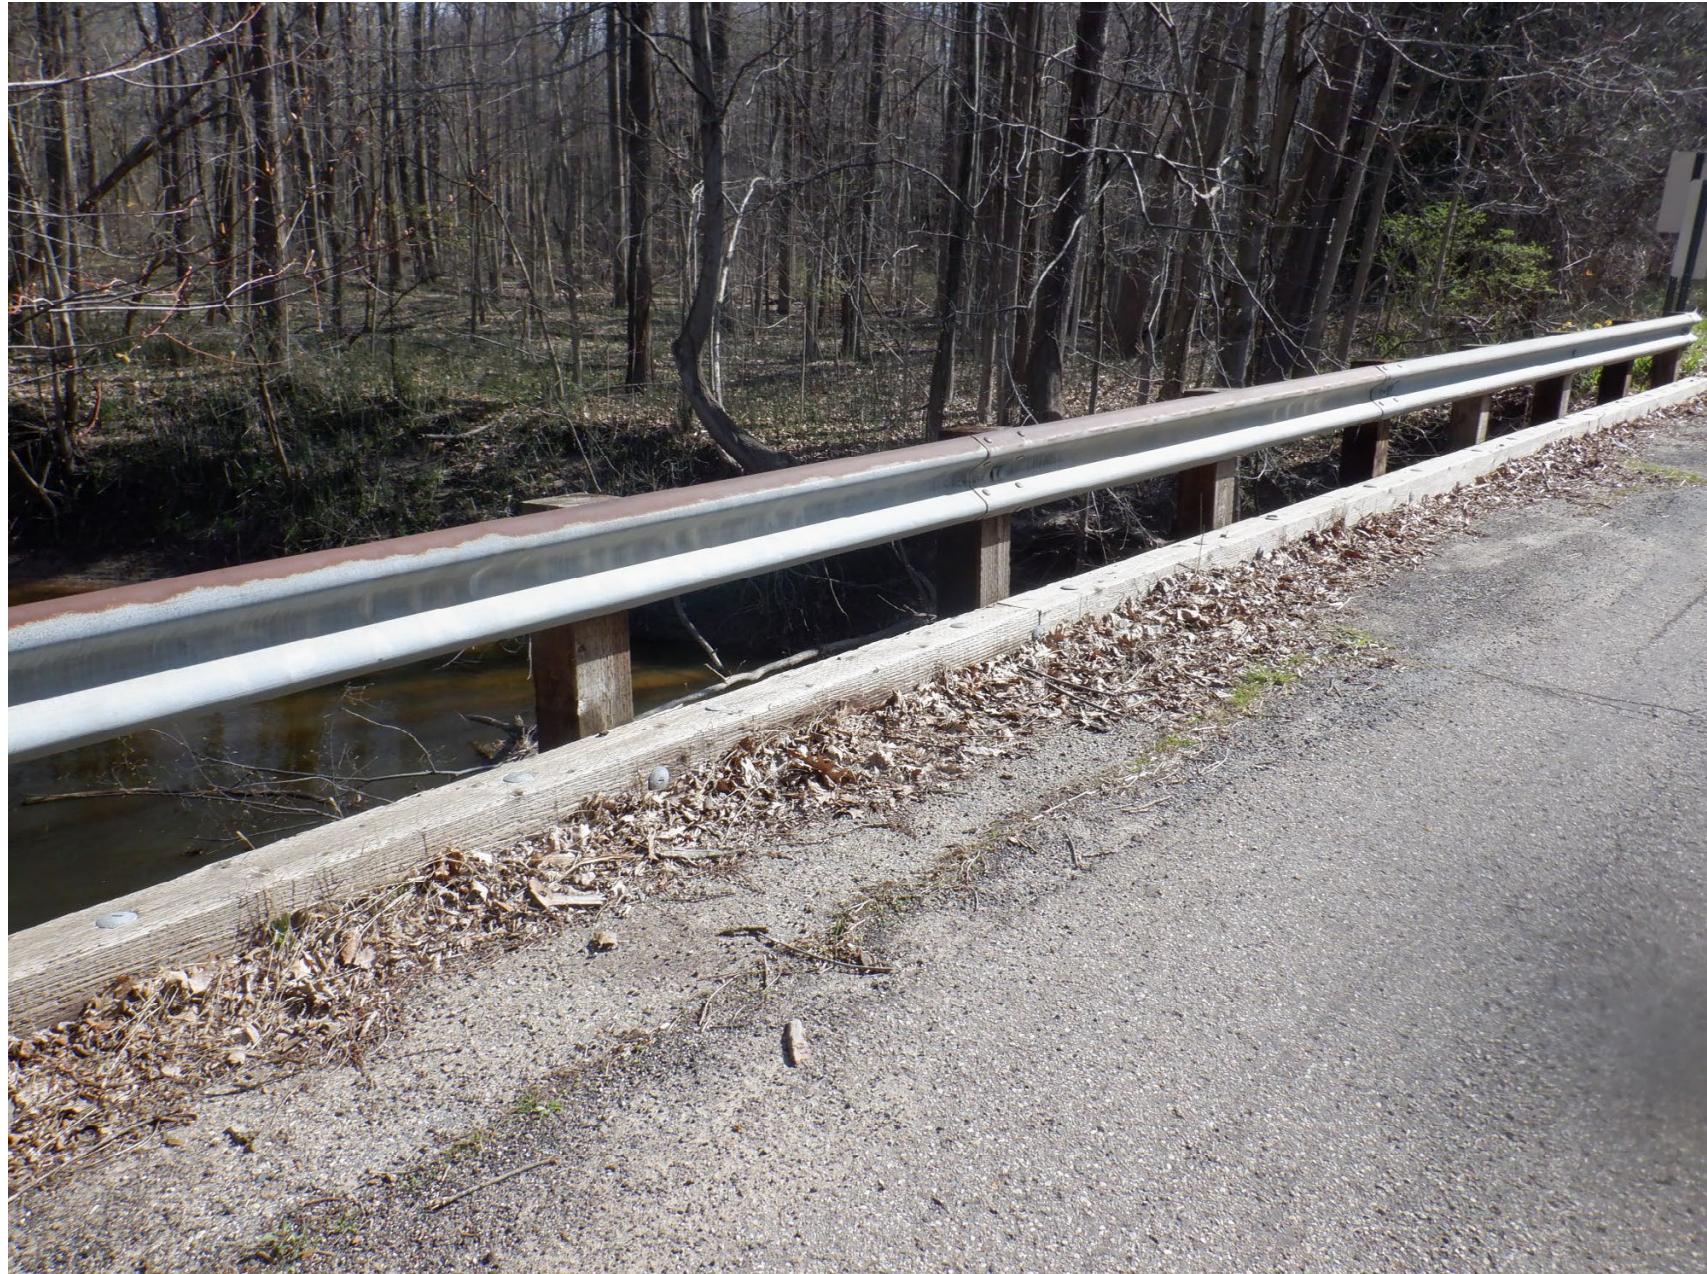
2. Expansion Joints	N	N	N	(04/25) (04/24) (04/23)
3. Other Joints	N	N	N	(04/25) (04/24) (04/23)
4. Railings	3	3	3	North rail posts and brush block are newer. Bolts and rail beams are rusting. South rail panel has rust and minor damage. Several wood posts along south railing are split. Entire south brush block rotting, ends completely rotten. Vegetation growing out of south brush block. Able to push south rail out ~1" with foot, may not deflect a vehicle. Every other post on both sides is not bolted to rail. 1 nut missing on south rail post west end of center span. Bottom anchor bolt nuts missing under south fascia each side of west pier. (04/25) North rail posts and brush block were repaired in 2015. Bolts and rail beams are rusting. South rail panel has rust and minor damage. Several wood posts along south railing are split. Entire south brush block rotting, ends completely rotten. Vegetation growing out of south brush block. Able to push south rail out ~1" with foot, may not deflect a vehicle. Every other post on both sides is not bolted to rail. 1 nut missing on south rail post west end of center span. Bottom anchor bolt nuts missing under south fascia each side of west pier. (04/24) North rail posts and brush block were repaired in 2015. Bolts and rail beams are rusting. South rail panel has minor damage. Both panels have rust. Several wood posts along south railing are split. Entire south brush block rotting, ends completely rotten. Vegetation growing out of south brush block. Able to push south rail out ~1" with foot, may not deflect a vehicle. Every other post on both sides is not bolted to rail. 1 nut missing in south rail west end of center span. Bottom nuts missing in south rail each side of W pier. (04/23)

NORTH BRIDGE RAIL, W-BEAM RUSTING, NEWER POSTS AND BRUSH BLOCK

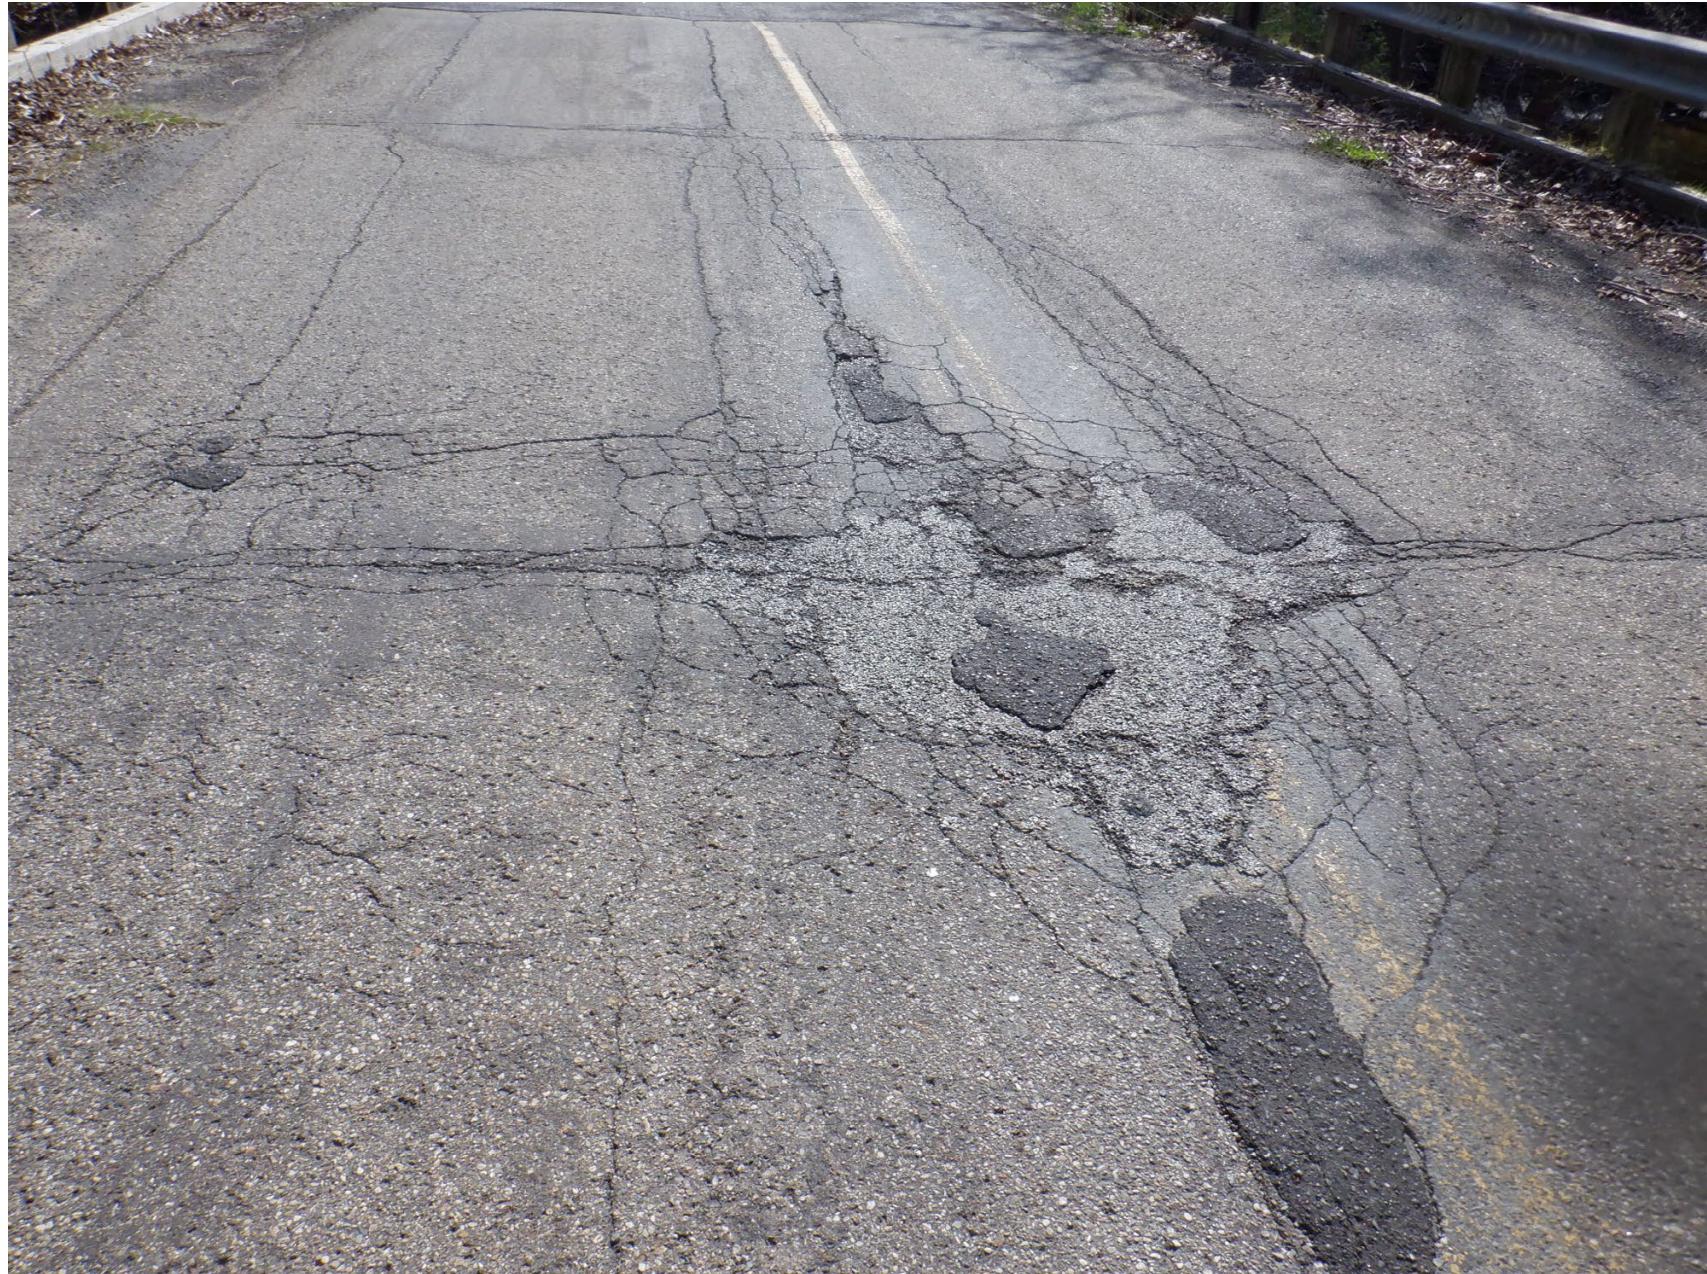
1. Surface (SIA-58A)	5	5	4	HMA skim coat over bridge. Transverse cracks over piers. Longitudinal cracks and settlement within 2' of centerline, worst is 1.25" over west pier where HMA is broken and patched. Additional longitudinal crack in east span WB lane and starting in EB lane, 2 longitudinal cracks in center span WB lane + 1 in EB lane. Map cracking in center span at west pier in WB lane. Dirt and debris along brush blocks. (04/25) HMA skim coat over bridge. Transverse cracks over piers. Longitudinal cracks and settlement within 2' of centerline, worst is 1.25" over west pier where HMA is broken and patched. Additional longitudinal crack in east span WB lane and starting in EB lane, 2 longitudinal cracks in center span WB lane + 1 in EB lane. Map cracking in center span at west pier in WB lane. Dirt and debris along brush blocks. (04/24) HMA skim coat over bridge. Transverse cracks over piers. Longitudinal cracks and settlement within 2' of centerline, worst is 1.25" over west pier where HMA is broken and patched. Additional longitudinal crack in east span WB lane and starting in EB lane, 2 longitudinal cracks in center span WB lane + 1 in EB lane. Map cracking in center span at west pier in WB lane. Dirt and debris along brush blocks. (04/23)

LONGITUDINAL AND ALLIGATOR CRACKS IN HMA SURFACE WITH SETTLEMENT AT CENTERLINE OVER WEST PIER

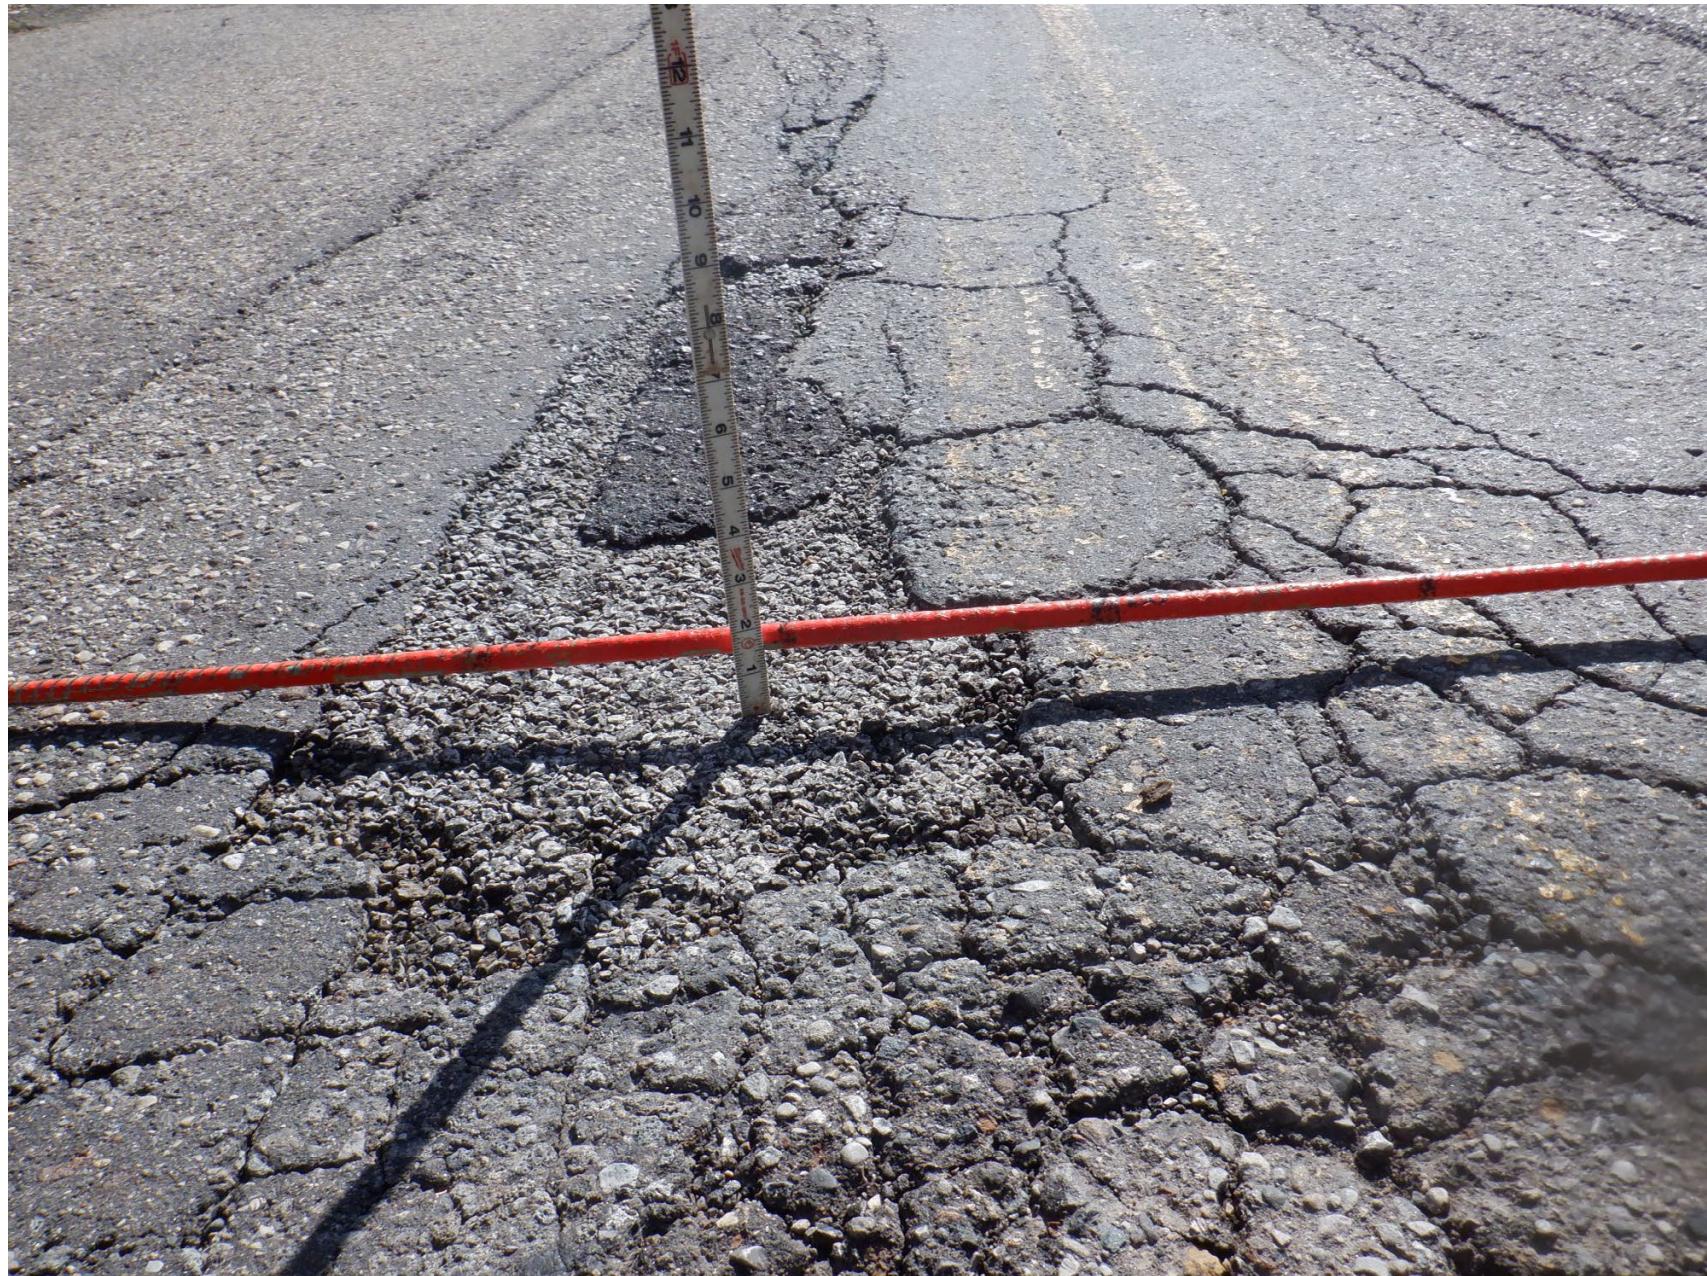
UP TO 1.25" SETTLEMENT AT CENTERLINE OVER WEST PIER

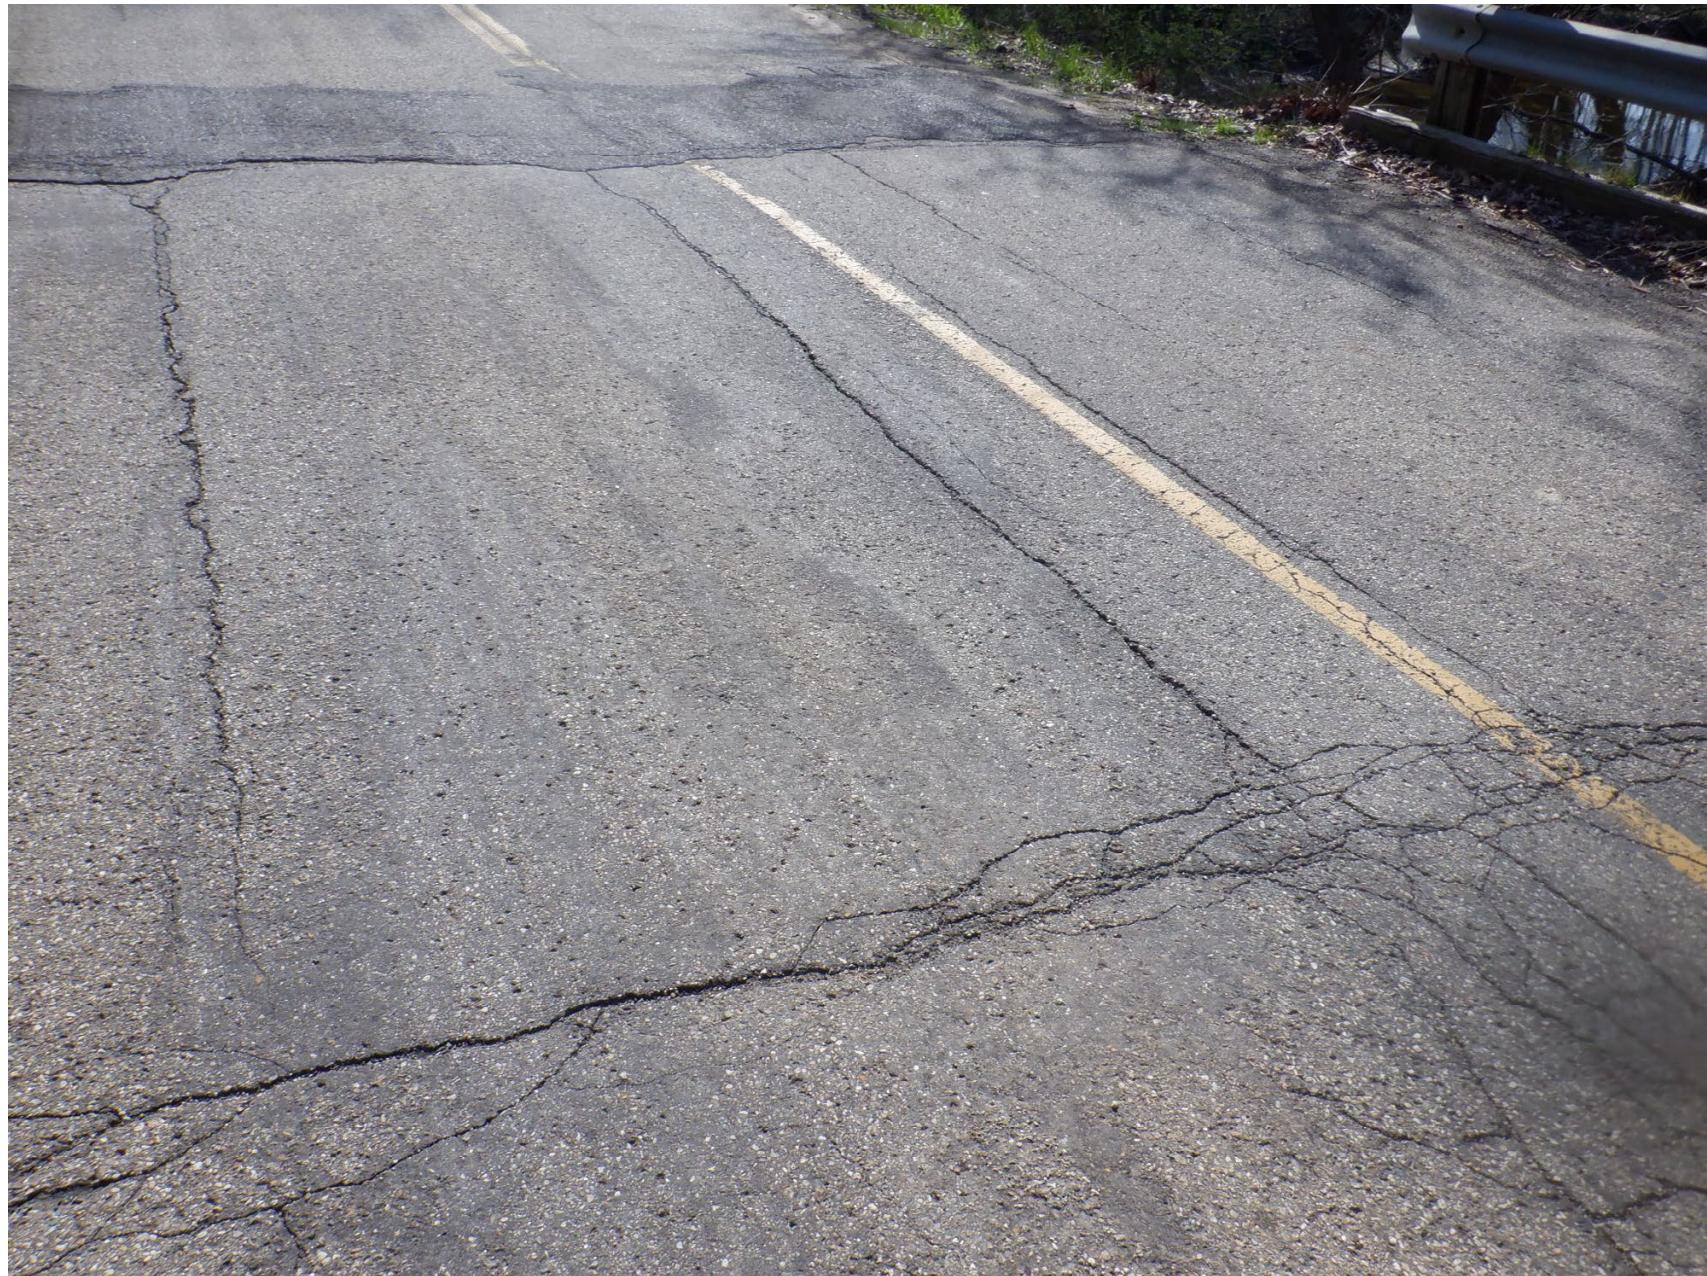
LONGITUDINAL CRACKS IN EAST SPAN, TRANSVERSE AND ALLIGATOR CRACKS OVER EAST PIER

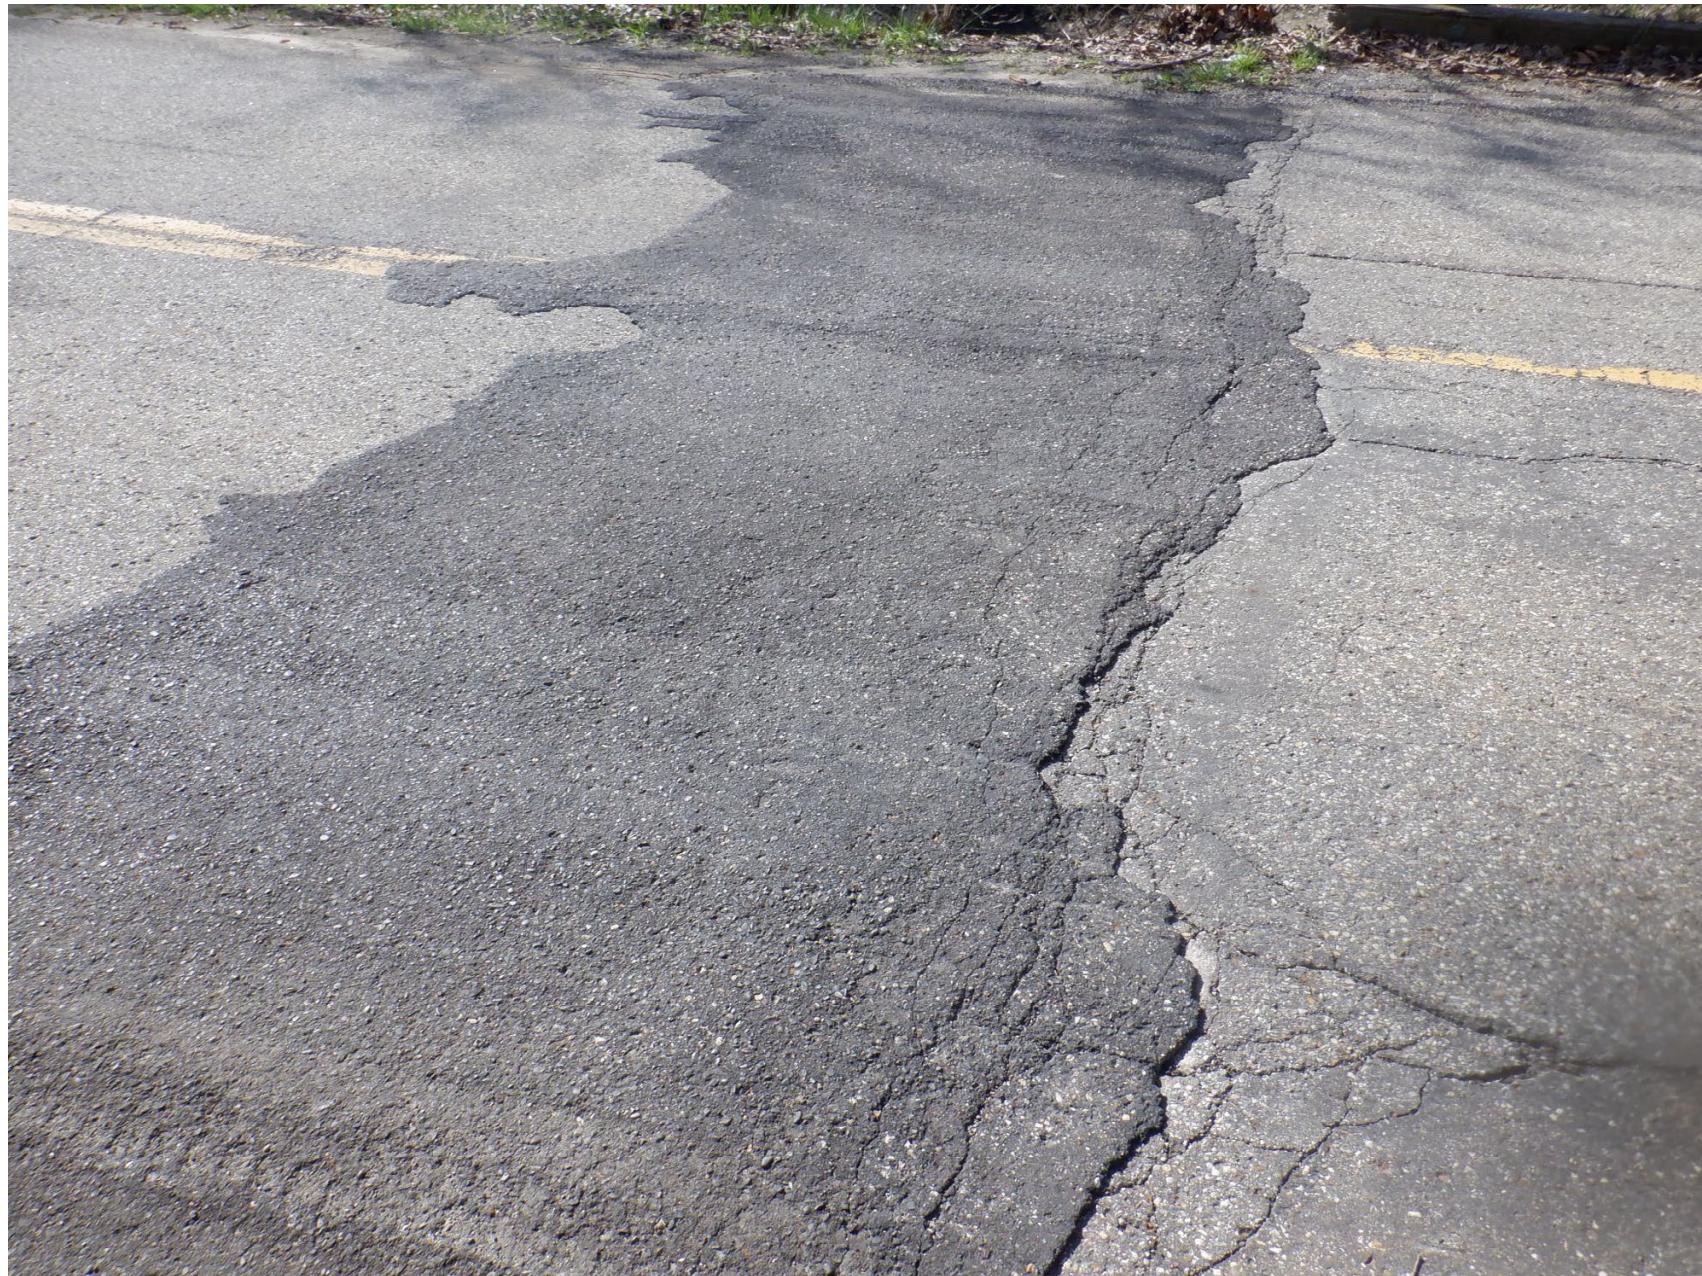
NEWER HMA WEDGING ON EAST APPROACH

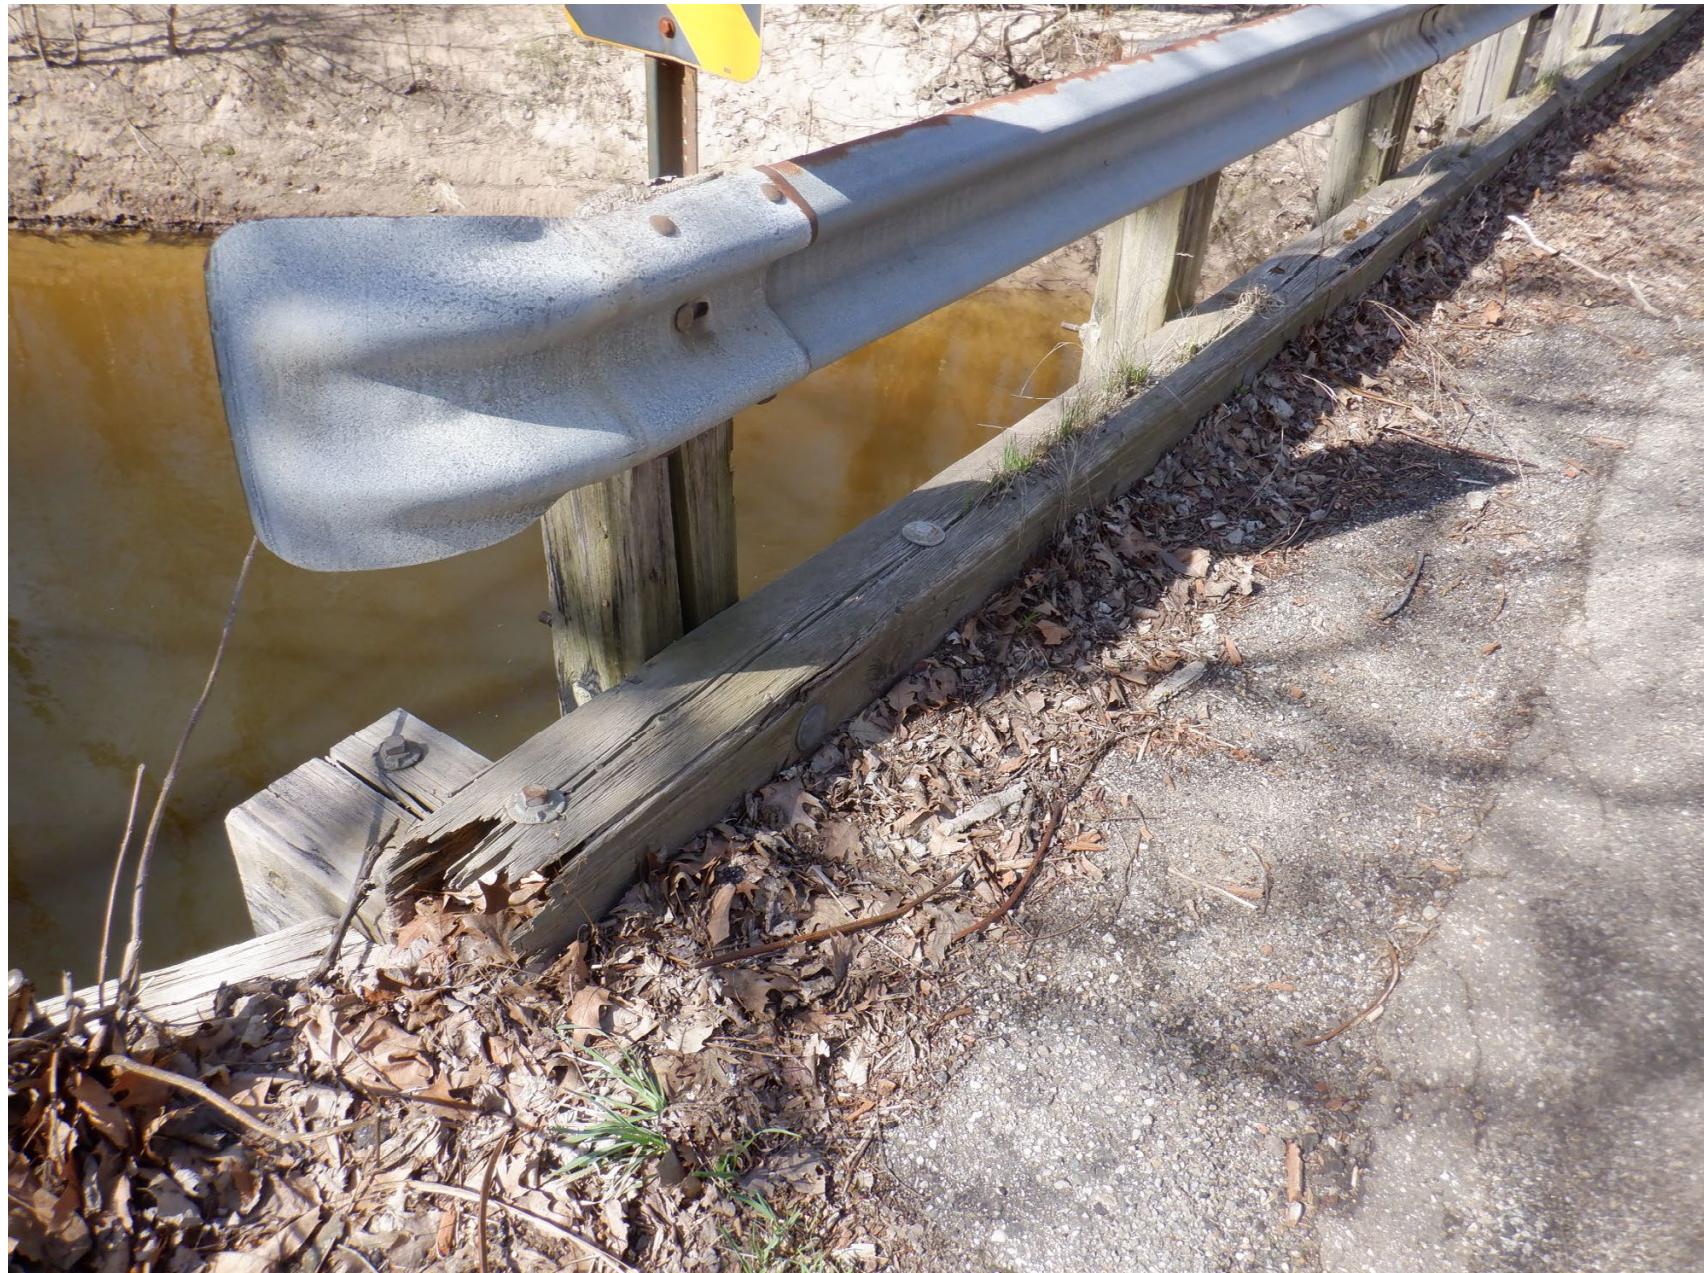
EAST END OF SOUTH BRUSH BLOCK ROTTING

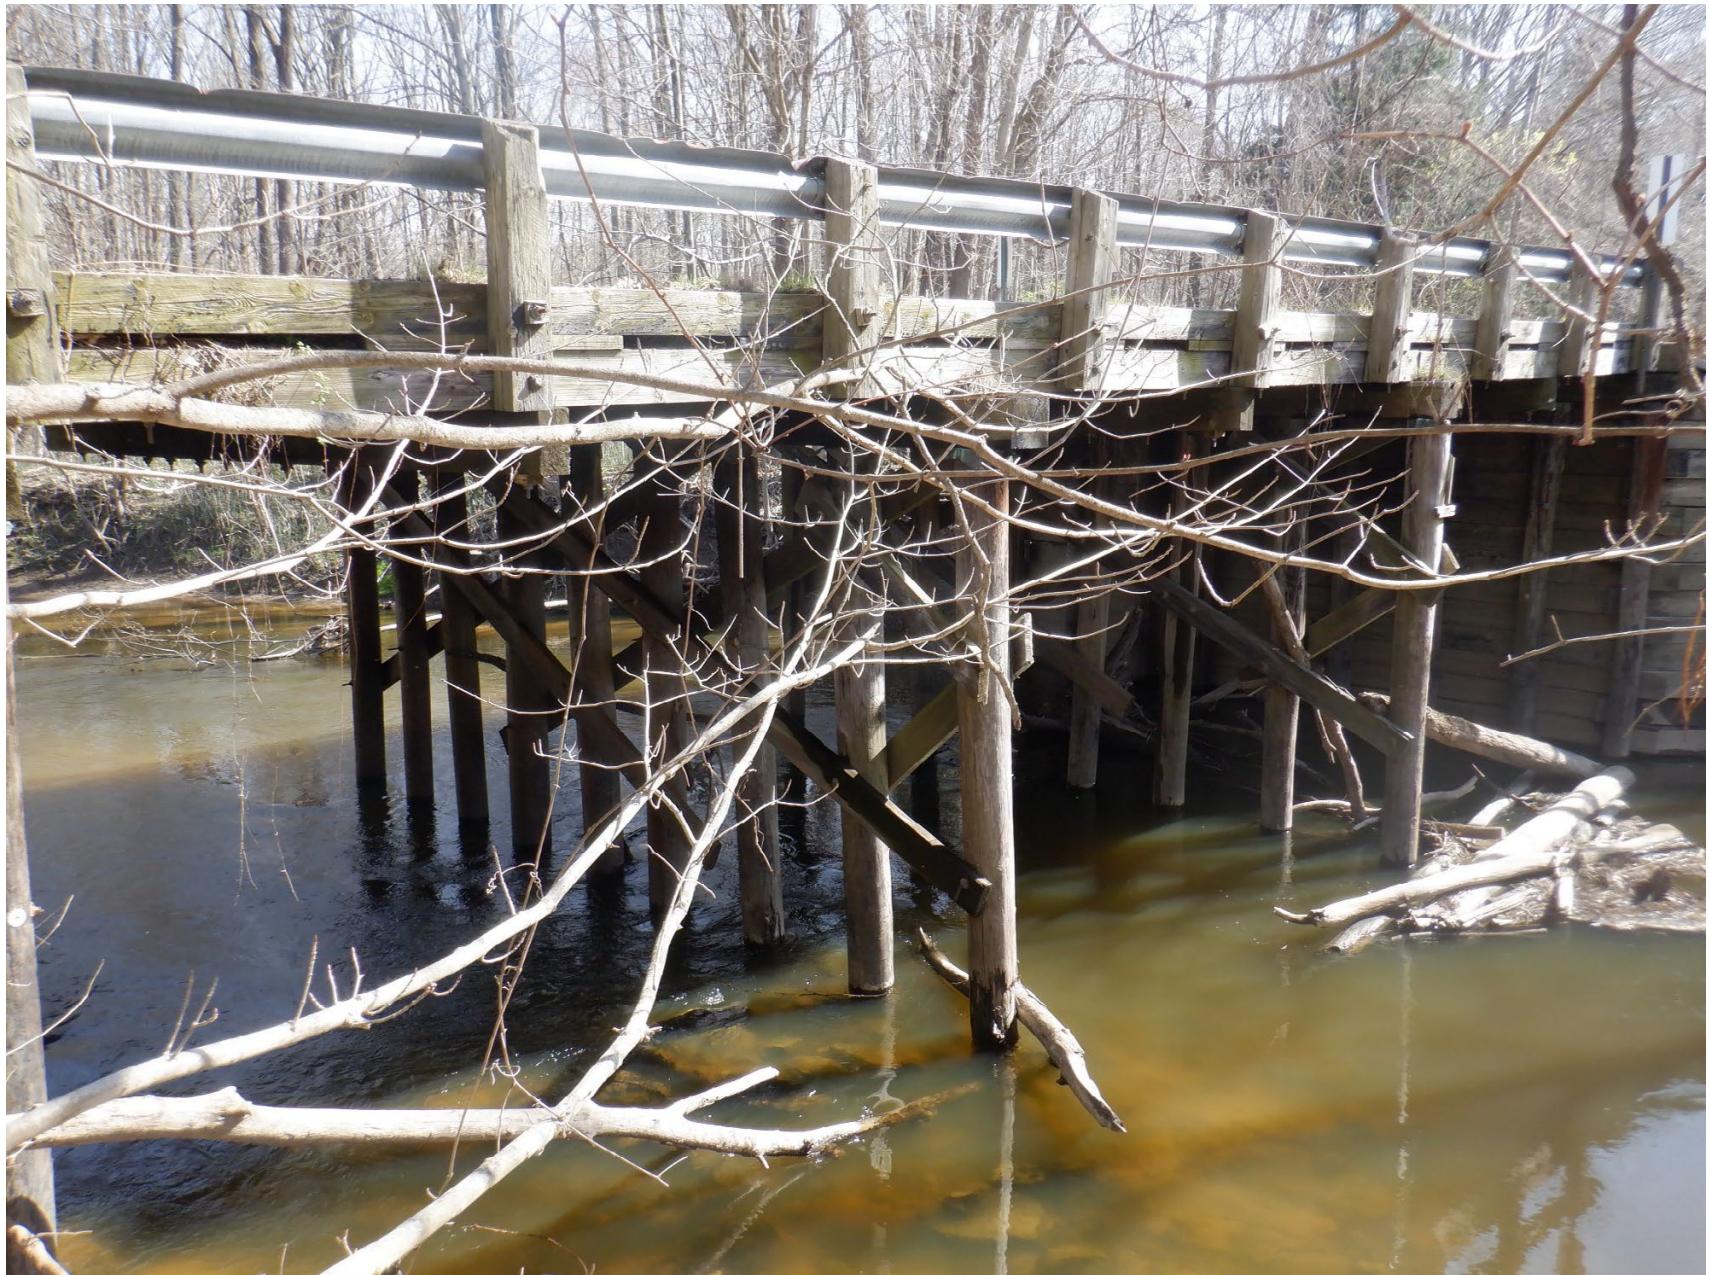
SOUTH BRIDGE ELEVATION
