REQUEST FOR PROPOSALS

8th Avenue over the South Branch of the Black River, Geneva Township (Structure #10769)

BRIDGE SAFETY INSPECTION REPORT			
STR 10769			
Facility	Latitude / Longitude	MDOT Structure ID	Structure Condition
8TH AVE	42.3893 / -86.2145	80309H00010B010	Poor Condition(4)
Feature	Length / Width / Spans	Owner	
S BR BLACK RIVER	53.8 / 29.5 / 3	County: Van Buren(80)	
Location	Built / Recon. / Paint / Ovly.	TSC	Operational Status
2.5 MI E OF SOUTH HAVEN	1967 / / /	Kalamazoo(16)	P Posted for load(314040)
Region / County	Material / Design	Last NBI Inspection	Scour Evaluation
Southwest(5) / Van Buren(80)	7 Wood or Timber / 01 Slab	04/24/2025 / PYS2	5 Stable w/in footing

Inspector Name	Agency / Company Name	Insp. Freq.	Insp. Date
Robert Lothschutz	Scott Civil Engineering Company	12	04/24/2025

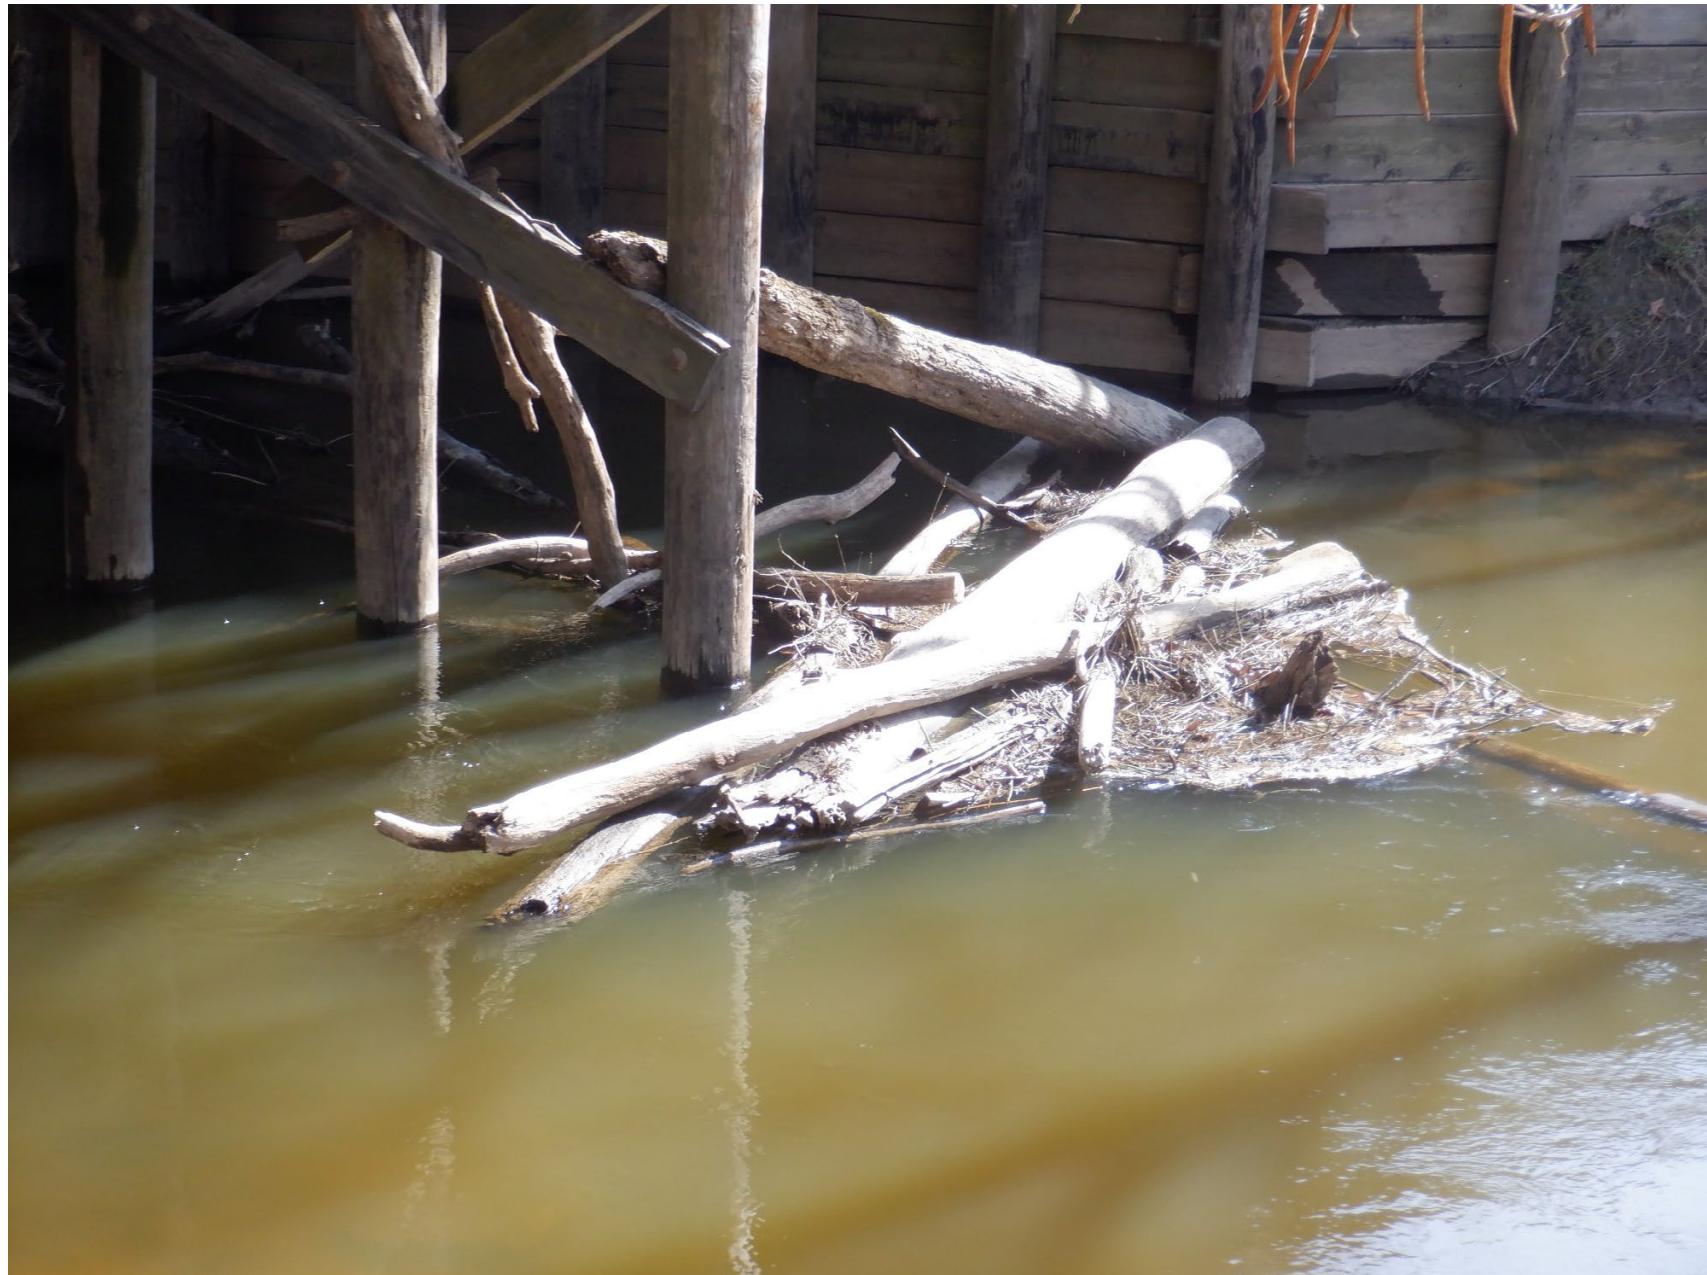
DEBRIS CAUGHT ON EAST PIER AND IN EAST SPAN

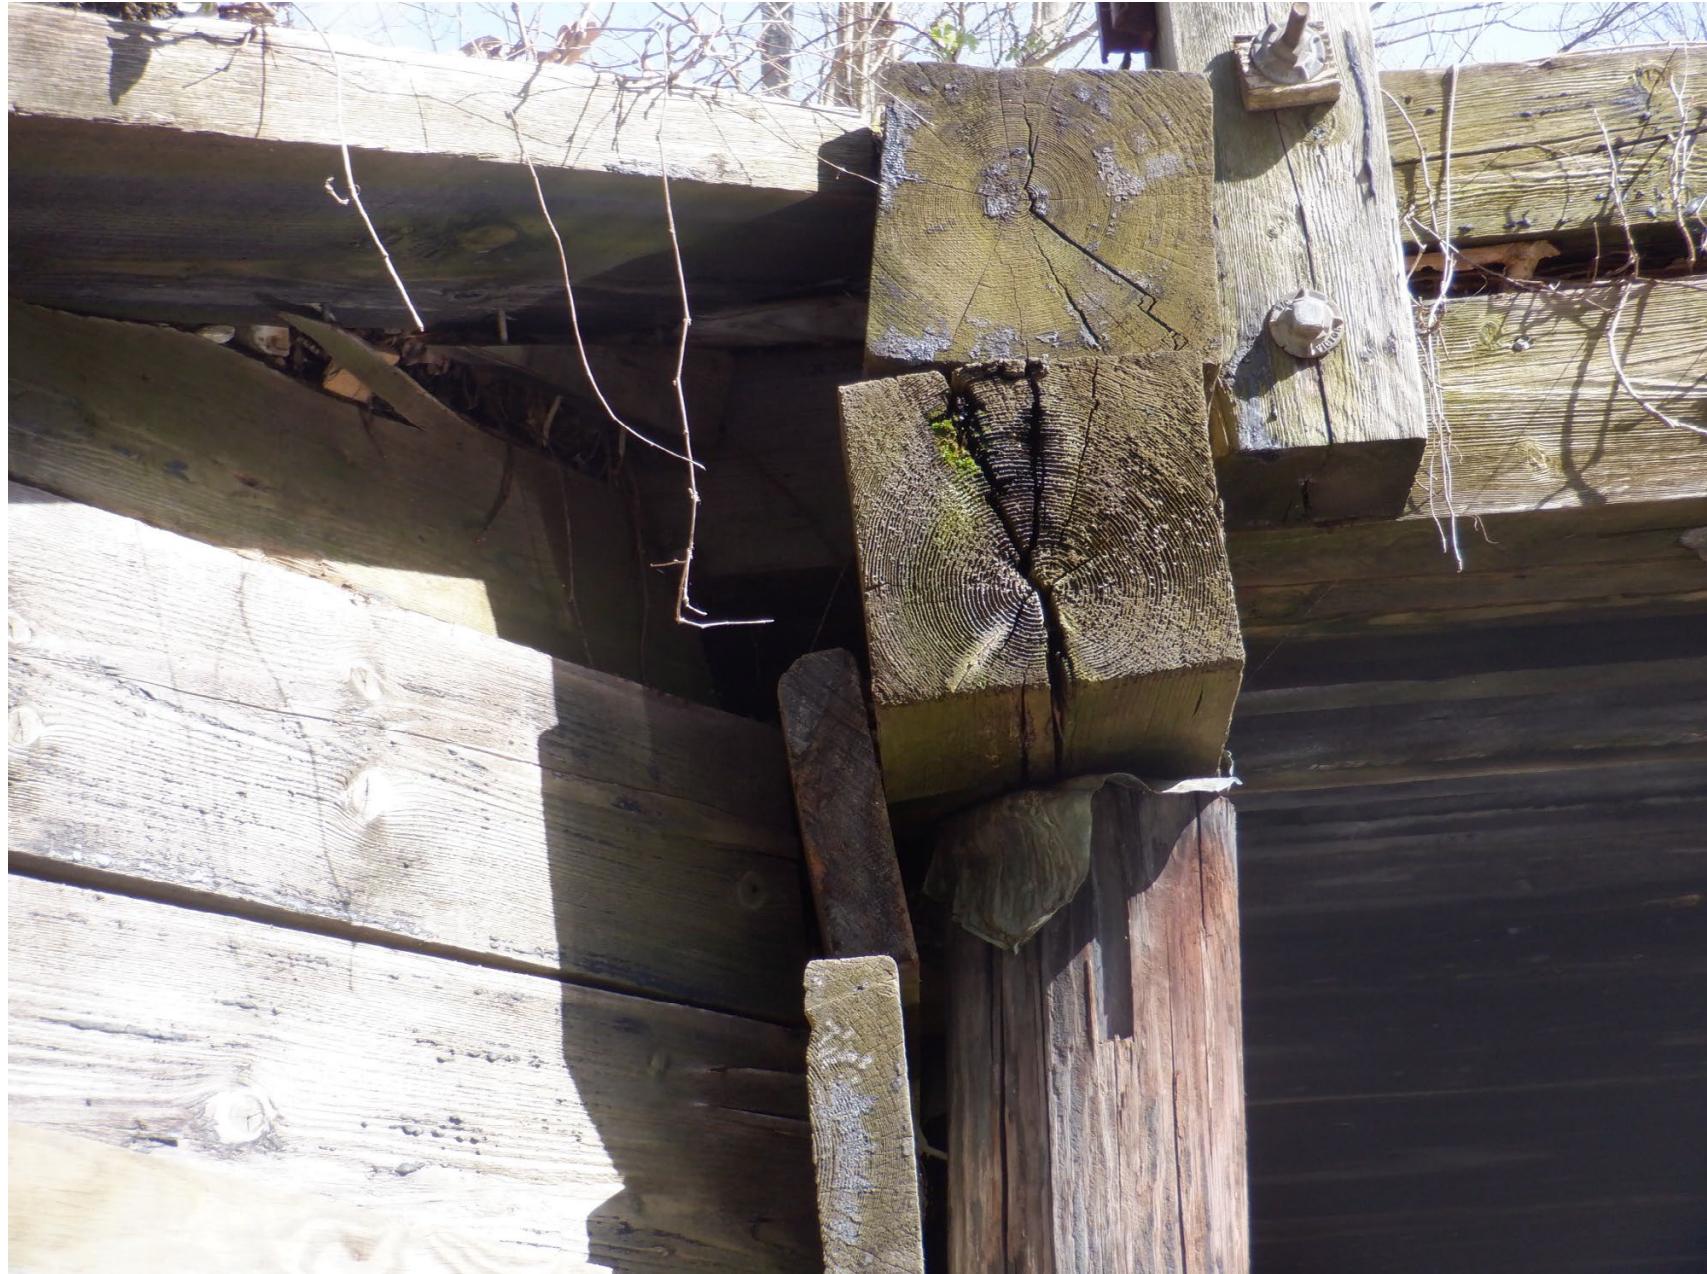
SPLIT AT SOUTH END OF WEST ABUTMENT CAP

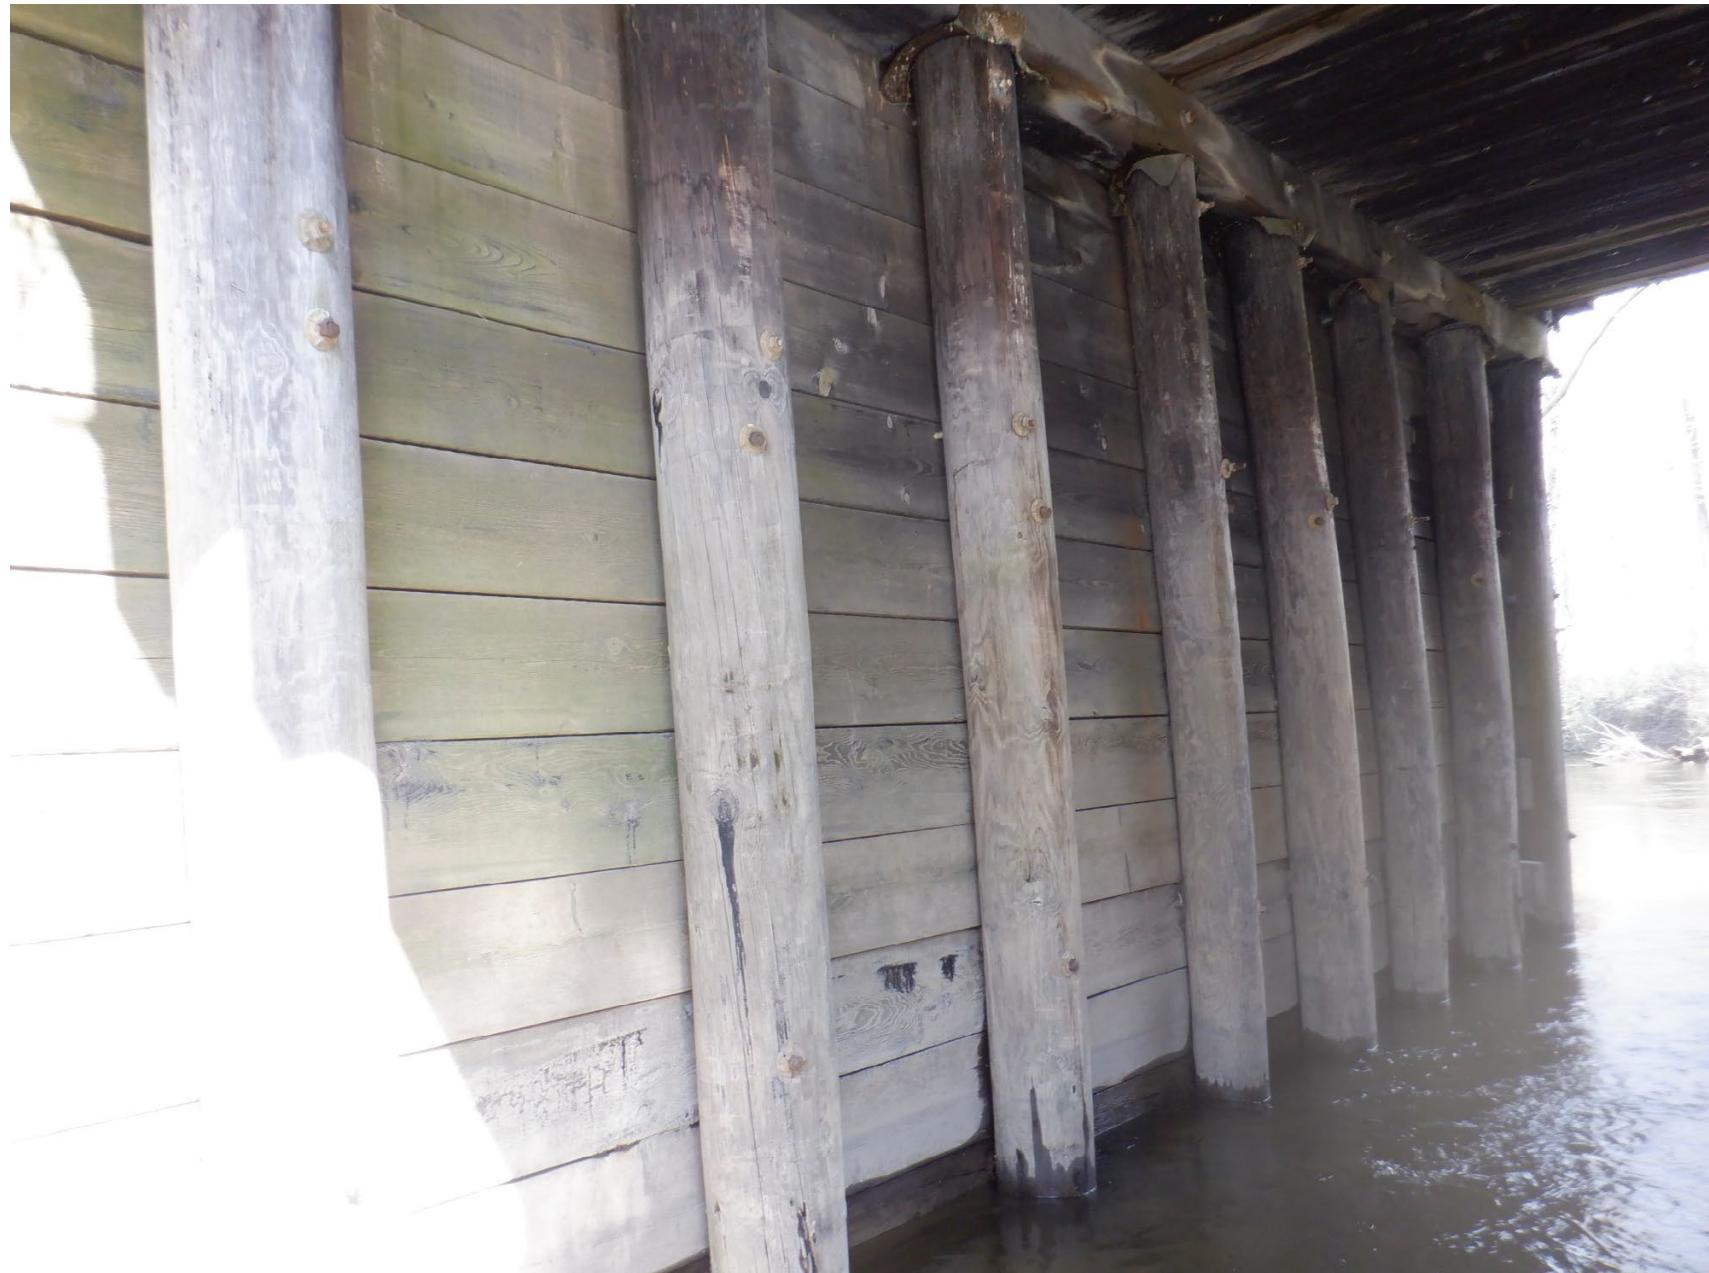
WEST ABUTMENT ELEVATION

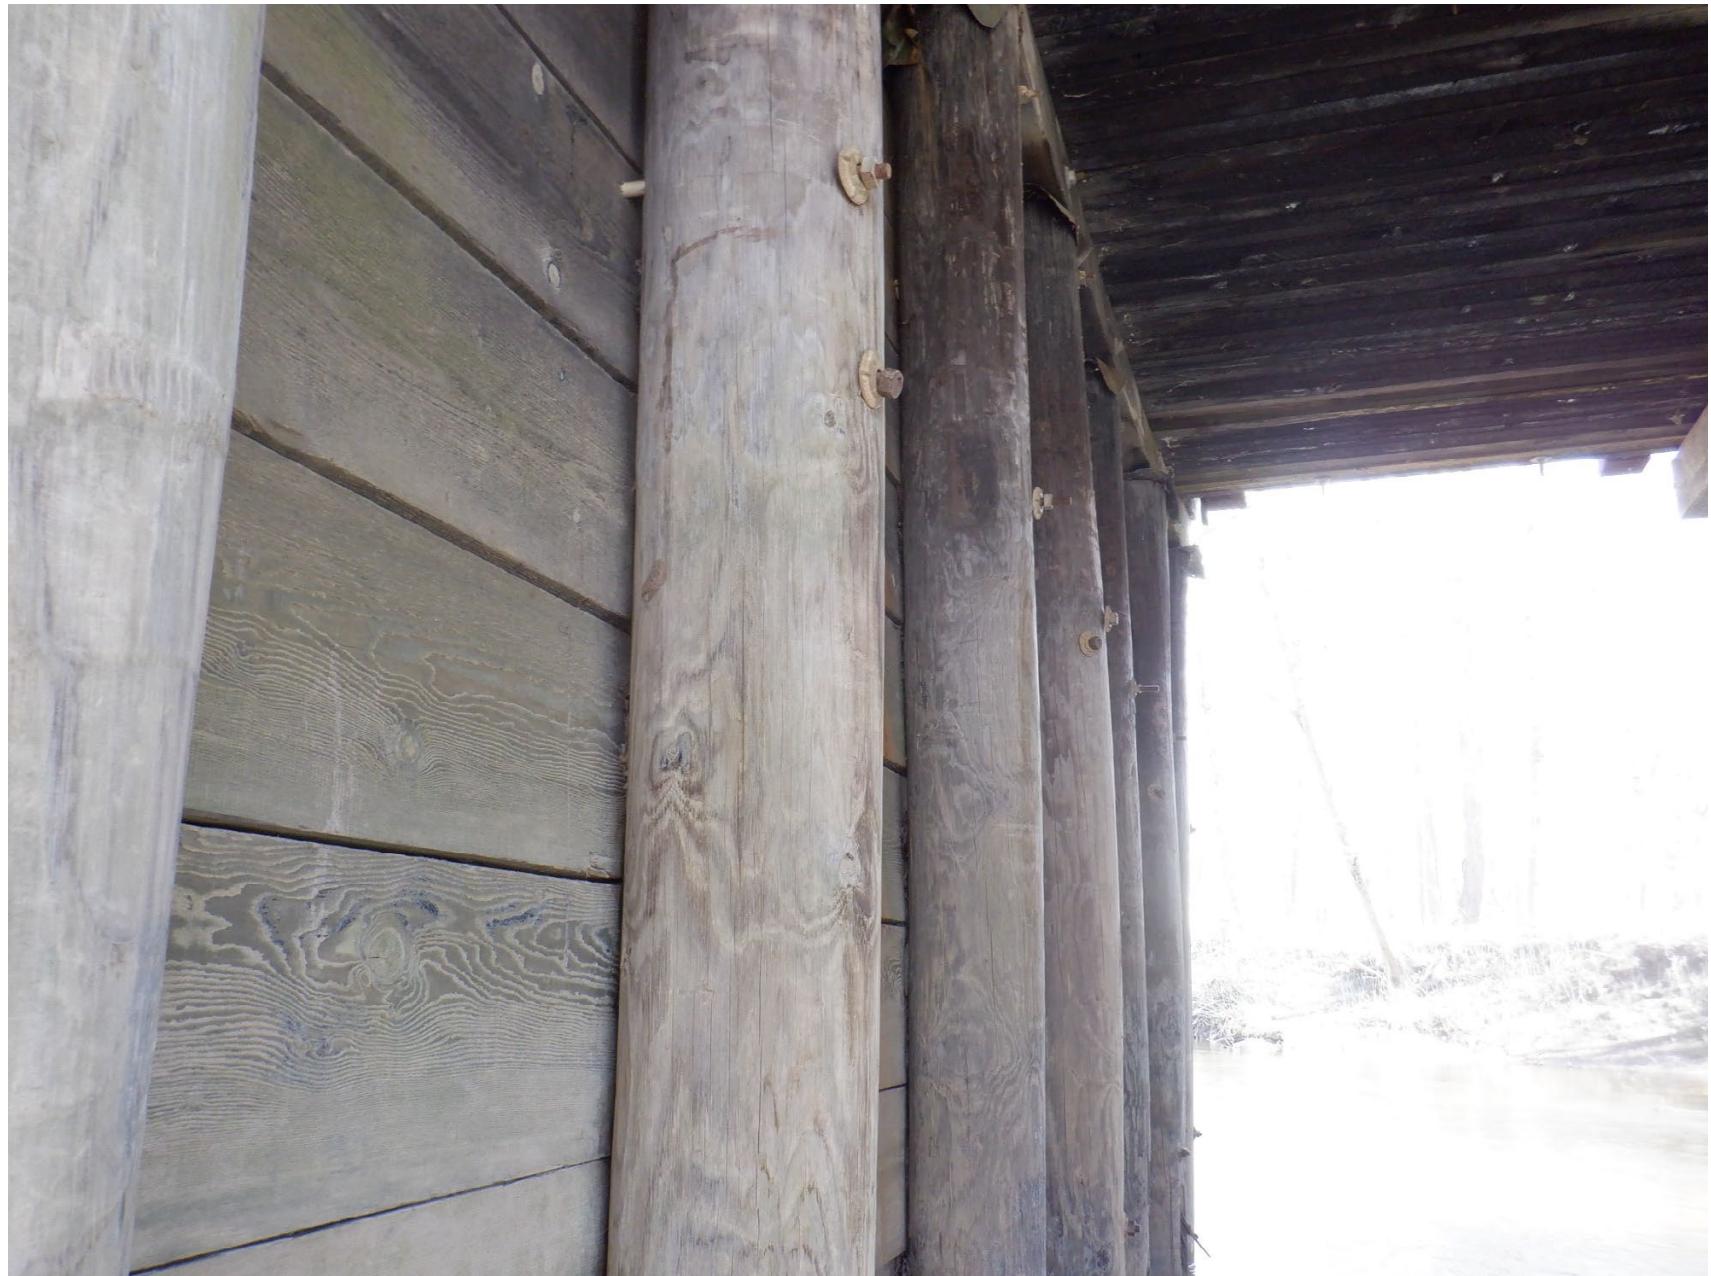
WEST ABUTMENT PILES BOWED IN NORTH HALF

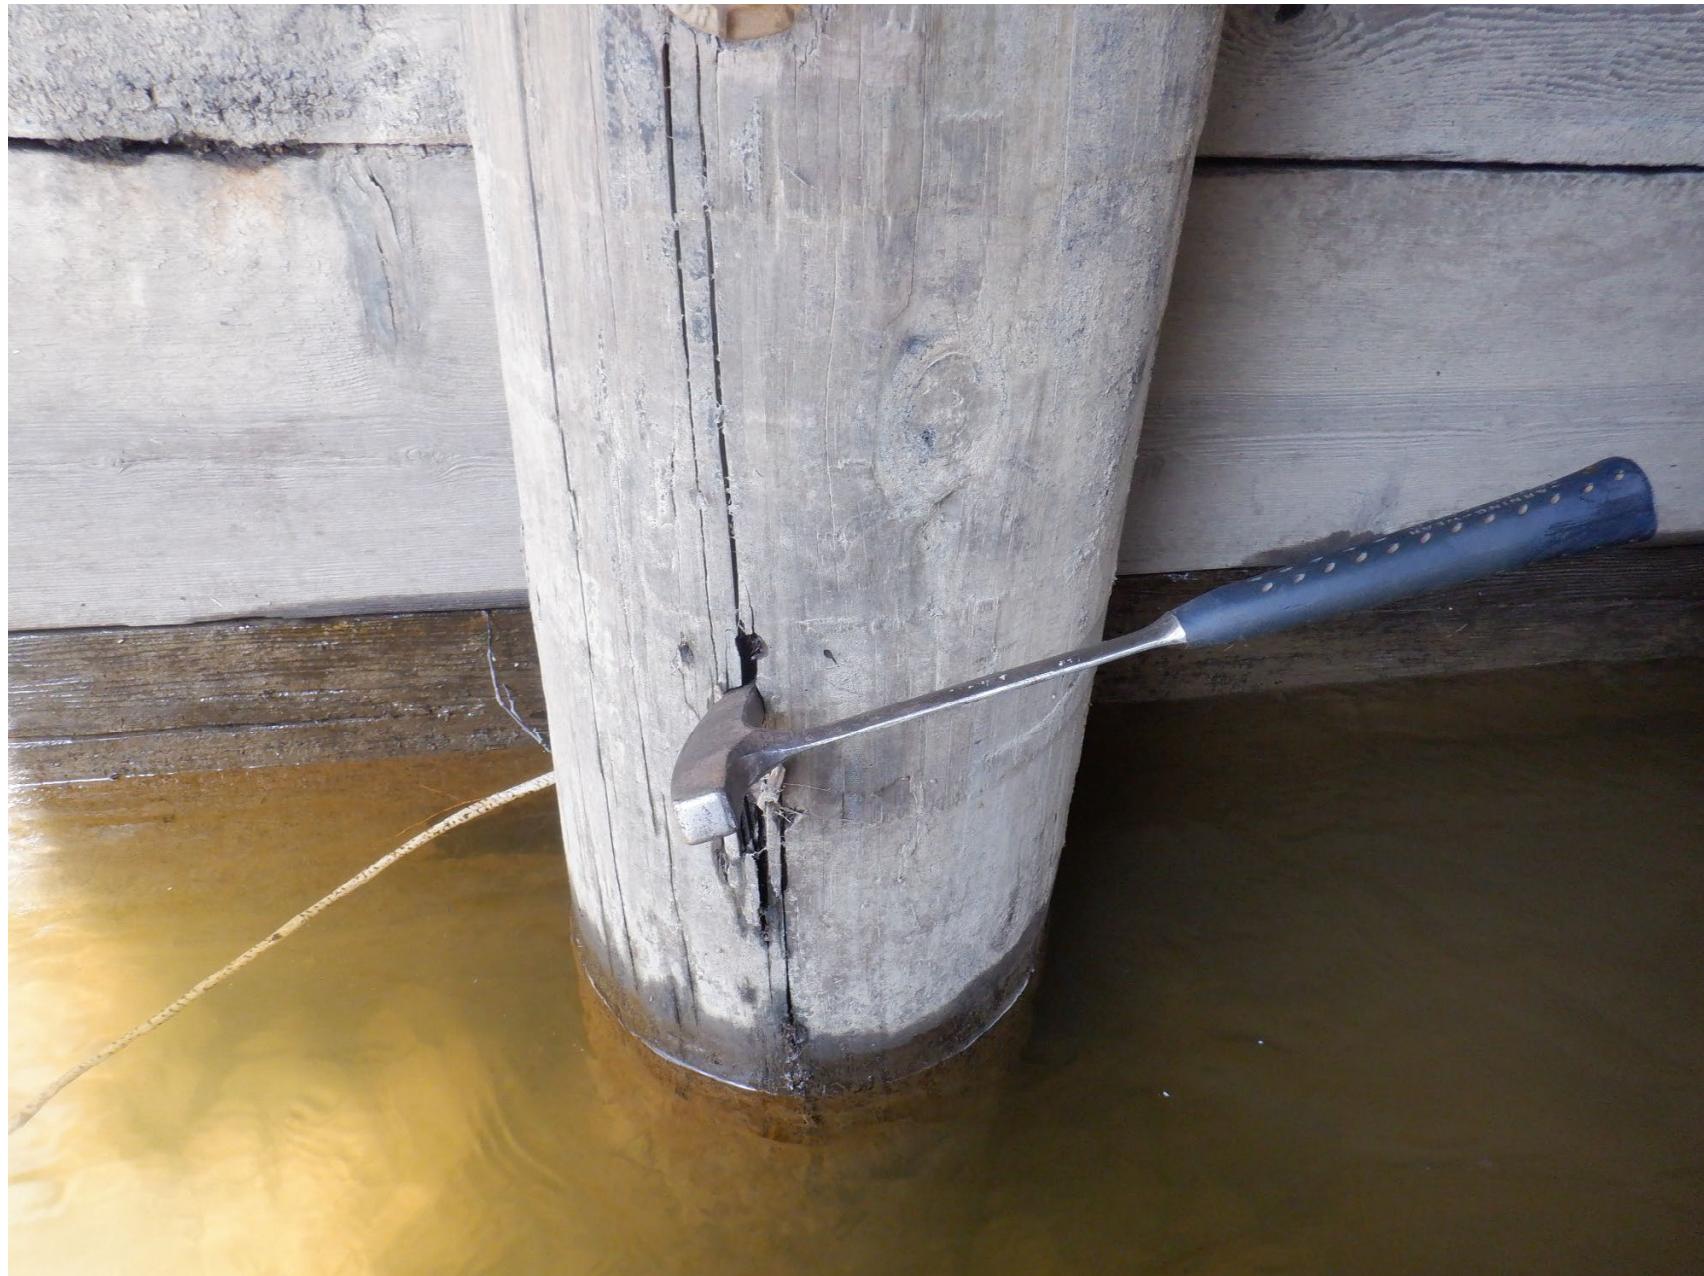
WEST ABUTMENT PILE 3S CHECKING WITH DECAY STARTING NEAR WATERLINE

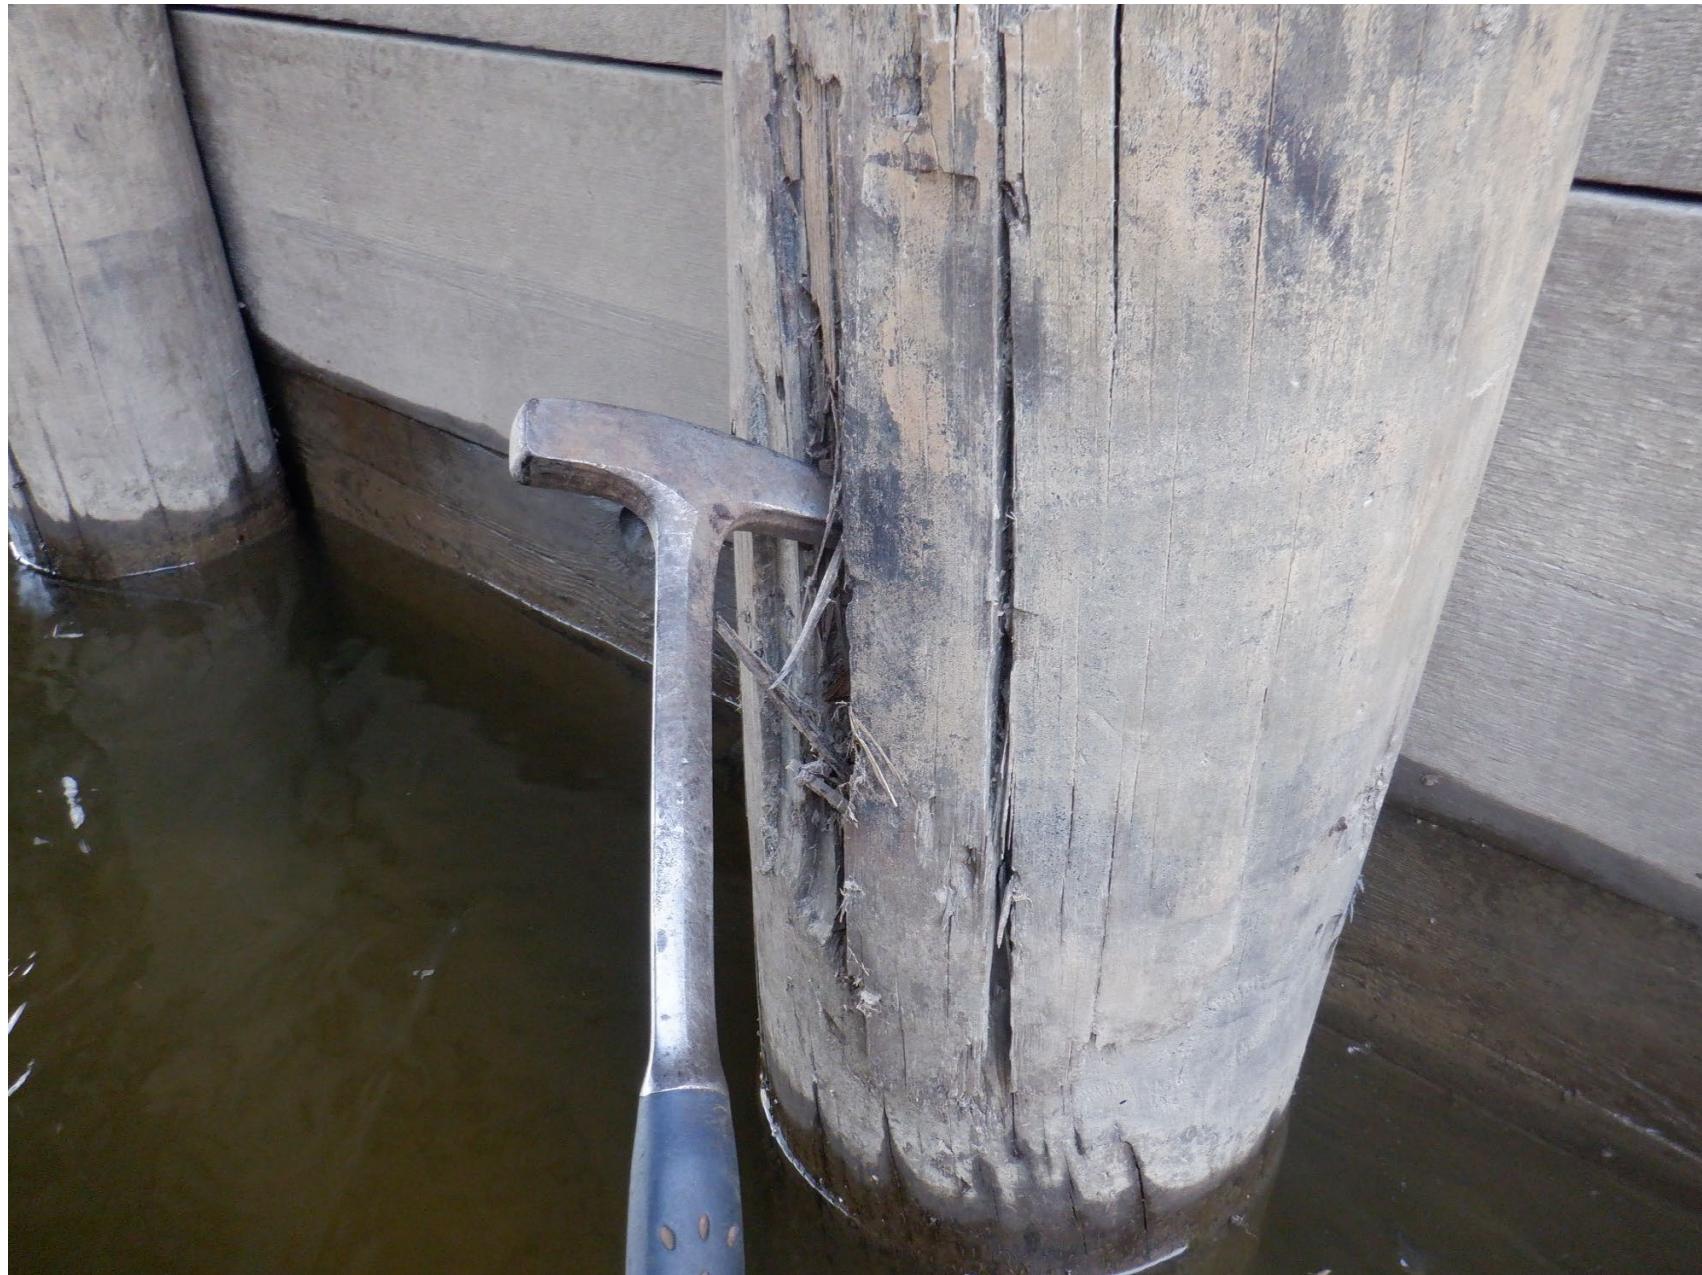
WEST ABUTMENT PILE 2N OUTER COVER CRACKED WITH ROT 2" DEEP ABOVE WATERLINE

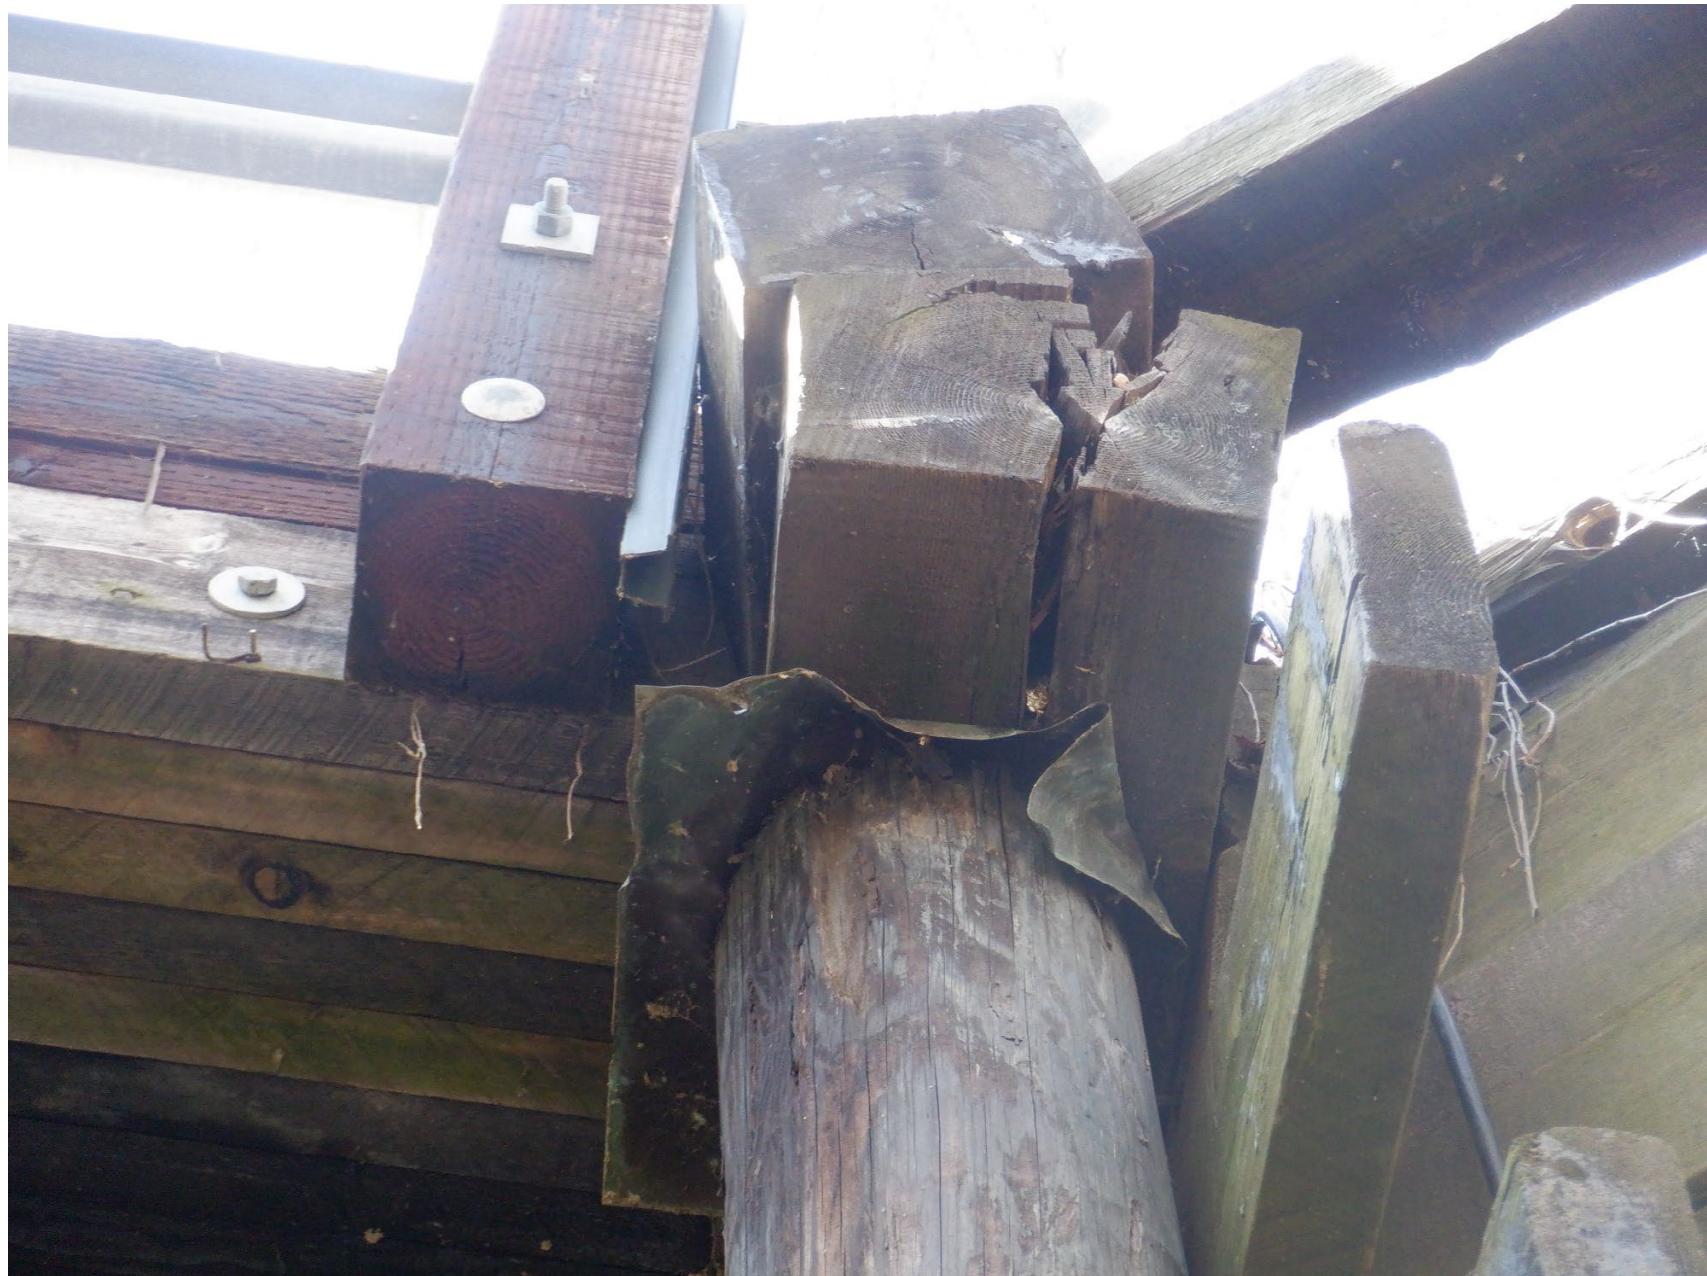
Poor. Posted at 31/40/40. Watch west abutment pile 2N and east abutment pile 4N. Monitor west abutment cap for any further rotation.

NORTH END OF WEST ABUTMENT CAP SPLIT AND ROTATED BACK

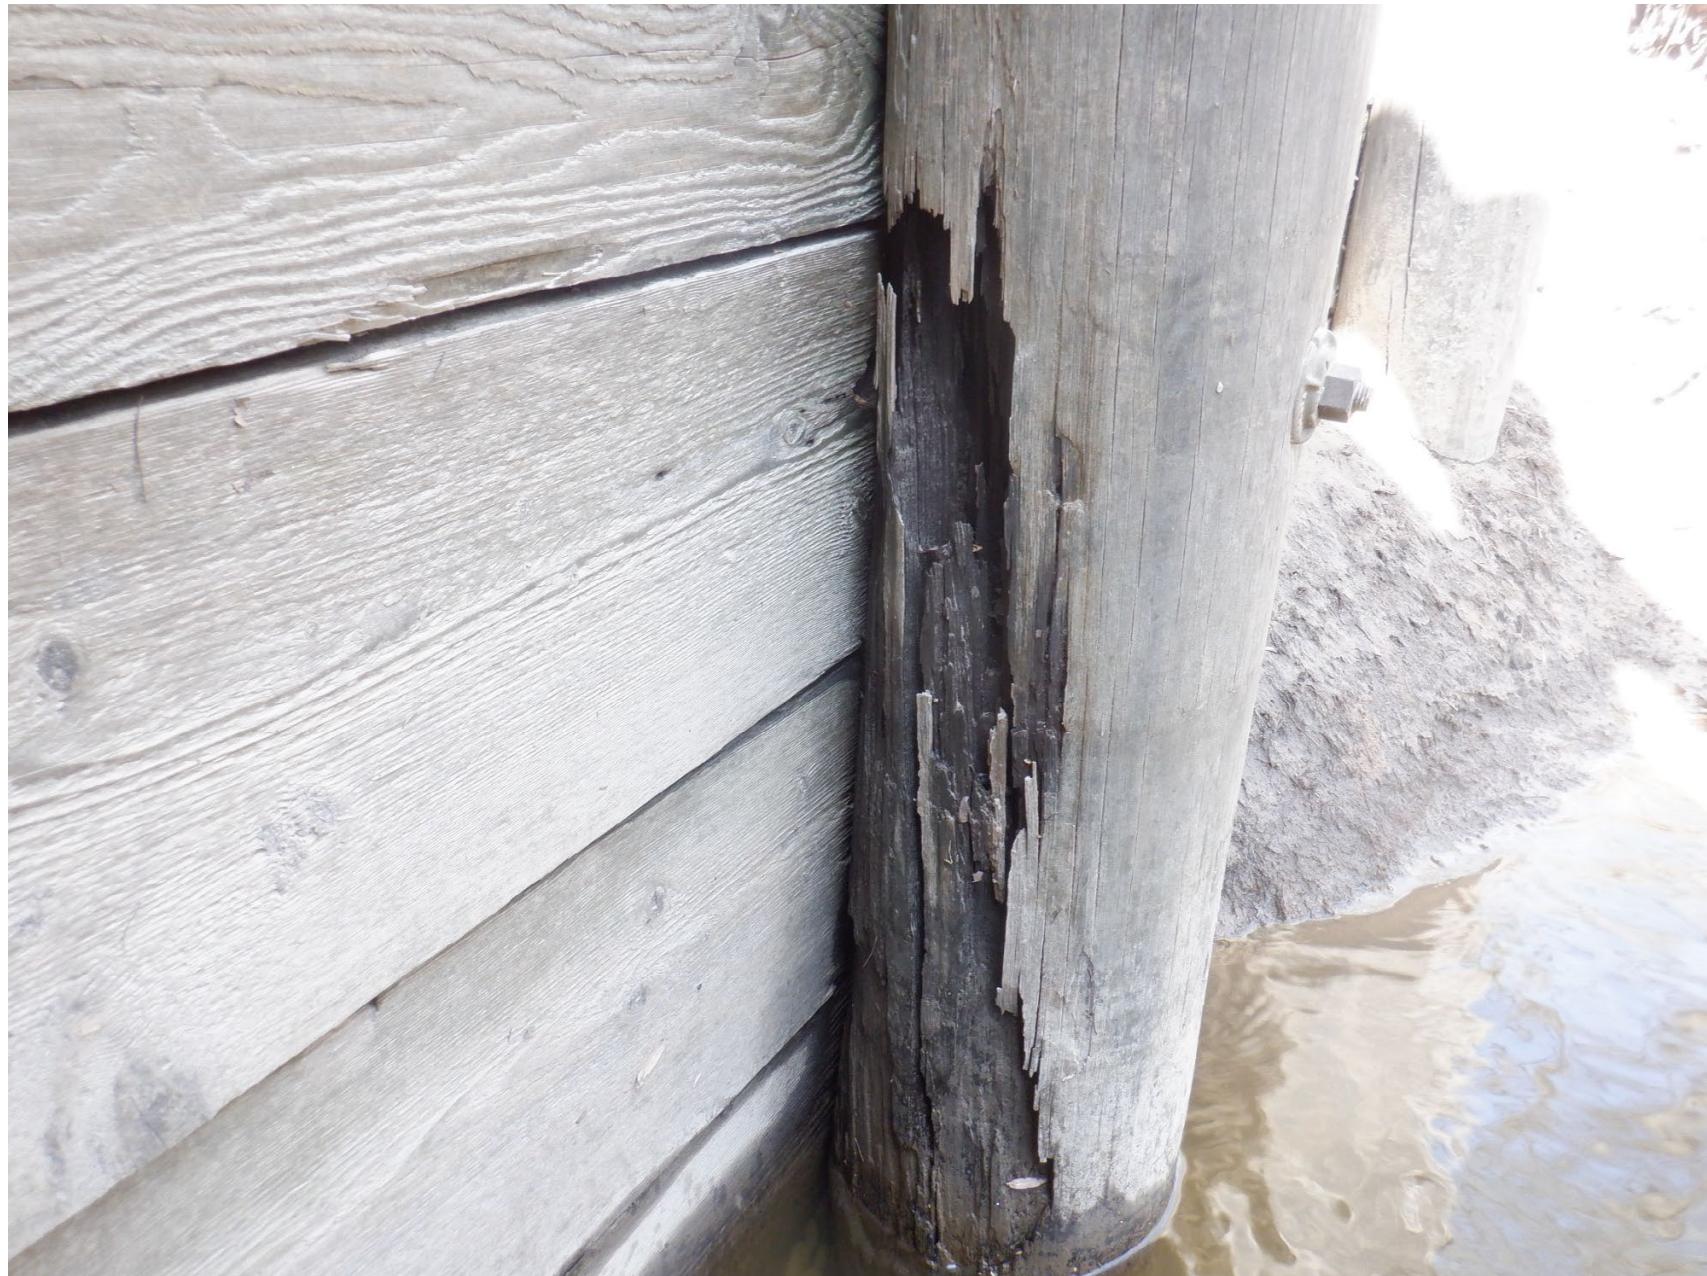
NORTHWEST WINGWALL PILE ROTTING

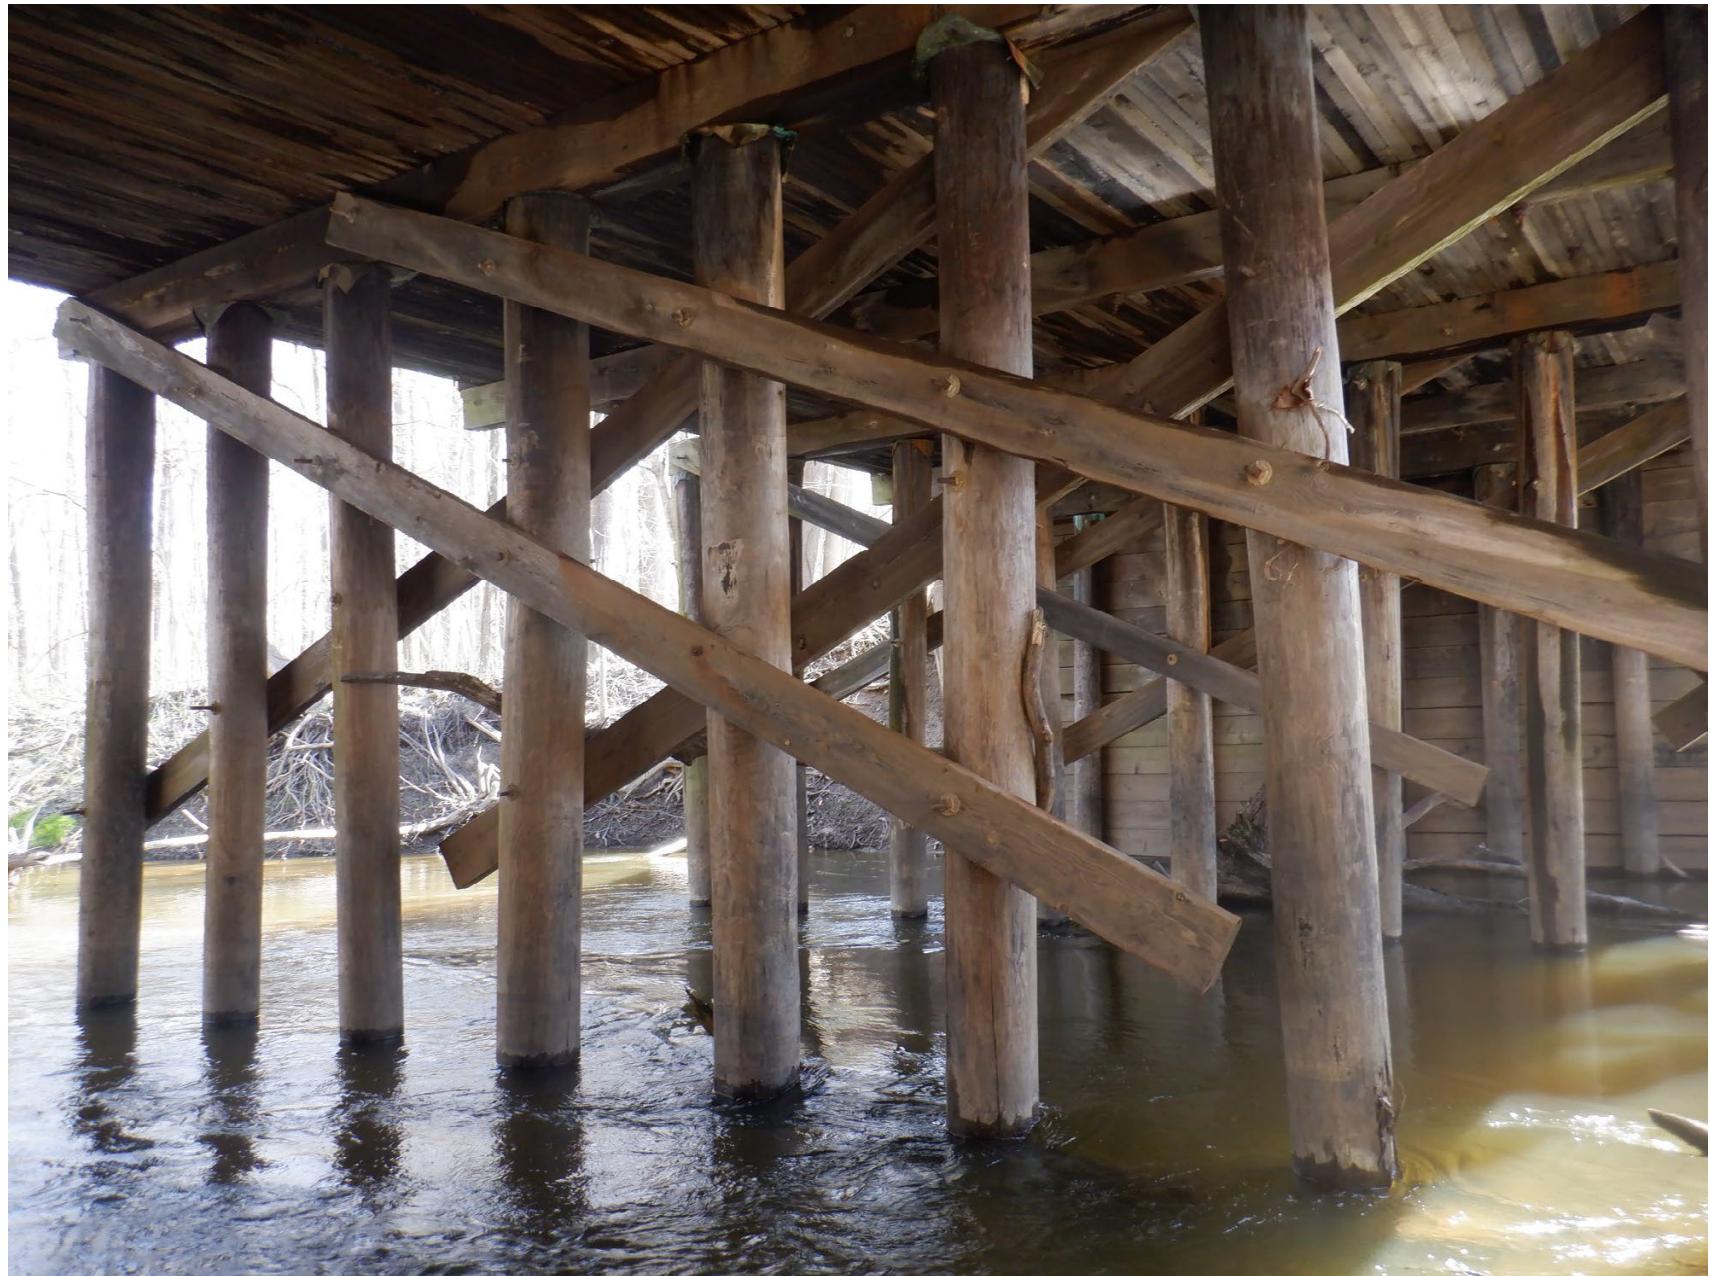
WEST PIER ELEVATION

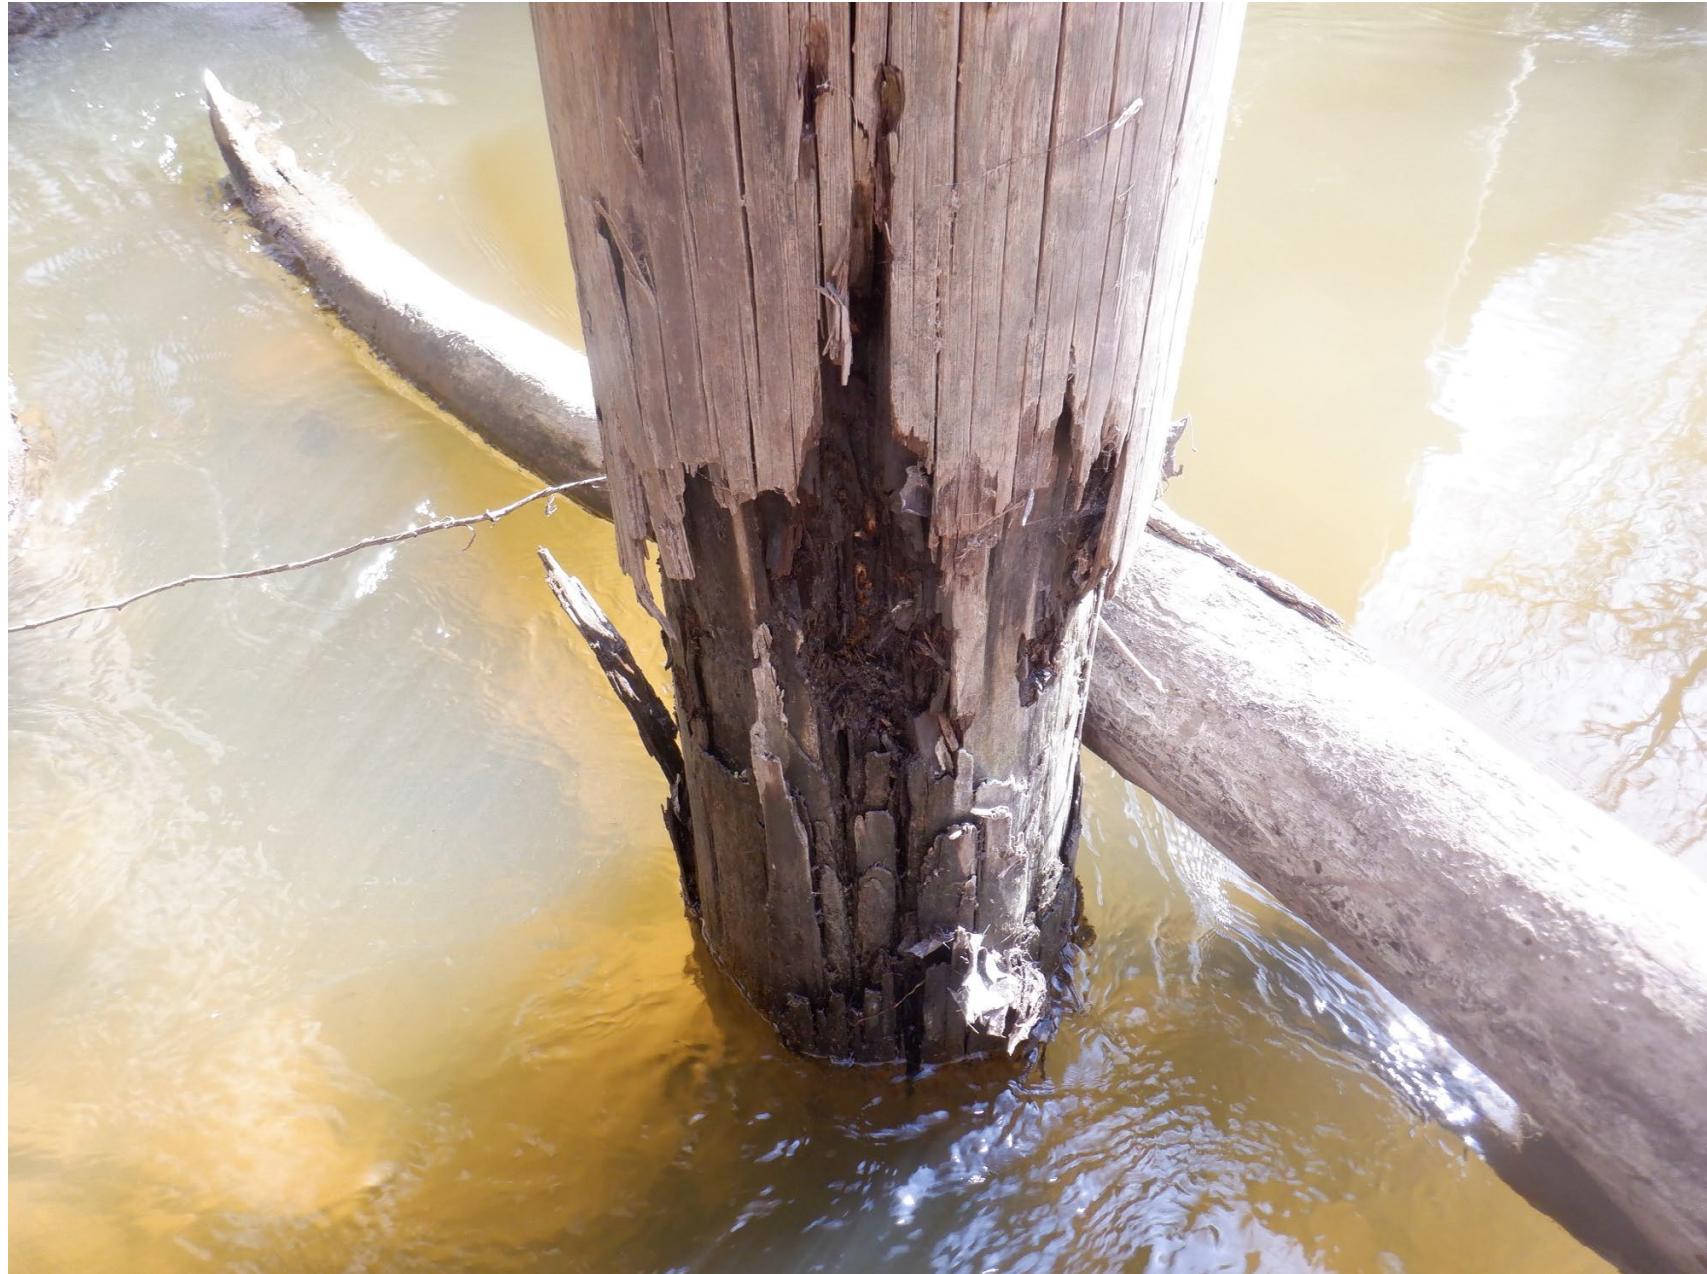
14. Piers (SIA-60)	5	5	5	<p>WEST PIER: Pile 3N & 4N have minor vertical splits at top. Pile 1S outer 1"-2" rotten at waterline. Pile 3S has surface decay at waterline. Leakage and checking noted on bottom of cap. Ends of cap starting to rot on top.</p> <p>EAST PIER: Pile 3N & 4S have minor vertical splits at top. Pile 1S starting to broom/decay at waterline. Pier cap has split along bottom, estimate up to 3/8" wide. Leakage noted on bottom of cap. Ends of cap starting to rot on top. (04/25)</p> <p>WEST PIER: Pile 3N & 4N have minor vertical splits at top. Pile 1S outer 1"-2" rotten at waterline. Pile 3S has surface decay at waterline. Leakage and checking noted on bottom of cap. Ends of cap starting to rot on top.</p> <p>EAST PIER: Pile 3N & 4S have minor vertical splits at top. Pile 1S starting to broom at waterline. Pier cap has split along bottom. Leakage noted on bottom of cap. Ends of cap starting to rot on top. (04/24)</p> <p>WEST PIER: Pile 3N & 4N have minor vertical splits at top. Pile 1S is broomed at waterline, outer 1" rotten (under water at time of inspection). Pile 3S starting to broom at waterline. Leakage and checking noted on bottom of cap. Ends of cap starting to rot on top.</p> <p>EAST PIER: Pile 3N & 4S have minor vertical splits at top. Pile 1S starting to broom below waterline. Pier cap has split along bottom. Leakage noted on bottom of cap. Ends of cap starting to rot on top. (04/23)</p>

OUTER 1"-2" ROTTING ON WEST PIER PILE 1S
