REQUEST FOR PROPOSALS

8th Avenue over the South Branch of the Black River, Geneva Township (Structure #10769)

BRIDGE SAFETY INSPECTION REPORT			
STR 10769			
Facility	Latitude / Longitude	MDOT Structure ID	Structure Condition
8TH AVE	42.3893 / -86.2145	80309H00010B010	Poor Condition(4)
Feature	Length / Width / Spans	Owner	
S BR BLACK RIVER	53.8 / 29.5 / 3	County: Van Buren(80)	
Location	Built / Recon. / Paint / Ovly.	TSC	Operational Status
2.5 MI E OF SOUTH HAVEN	1967 / / /	Kalamazoo(16)	P Posted for load(314040)
Region / County	Material / Design	Last NBI Inspection	Scour Evaluation
Southwest(5) / Van Buren(80)	7 Wood or Timber / 01 Slab	04/24/2025 / PYS2	5 Stable w/in footing

Inspector Name	Agency / Company Name	Insp. Freq.	Insp. Date
Robert Lothschutz	Scott Civil Engineering Company	12	04/24/2025

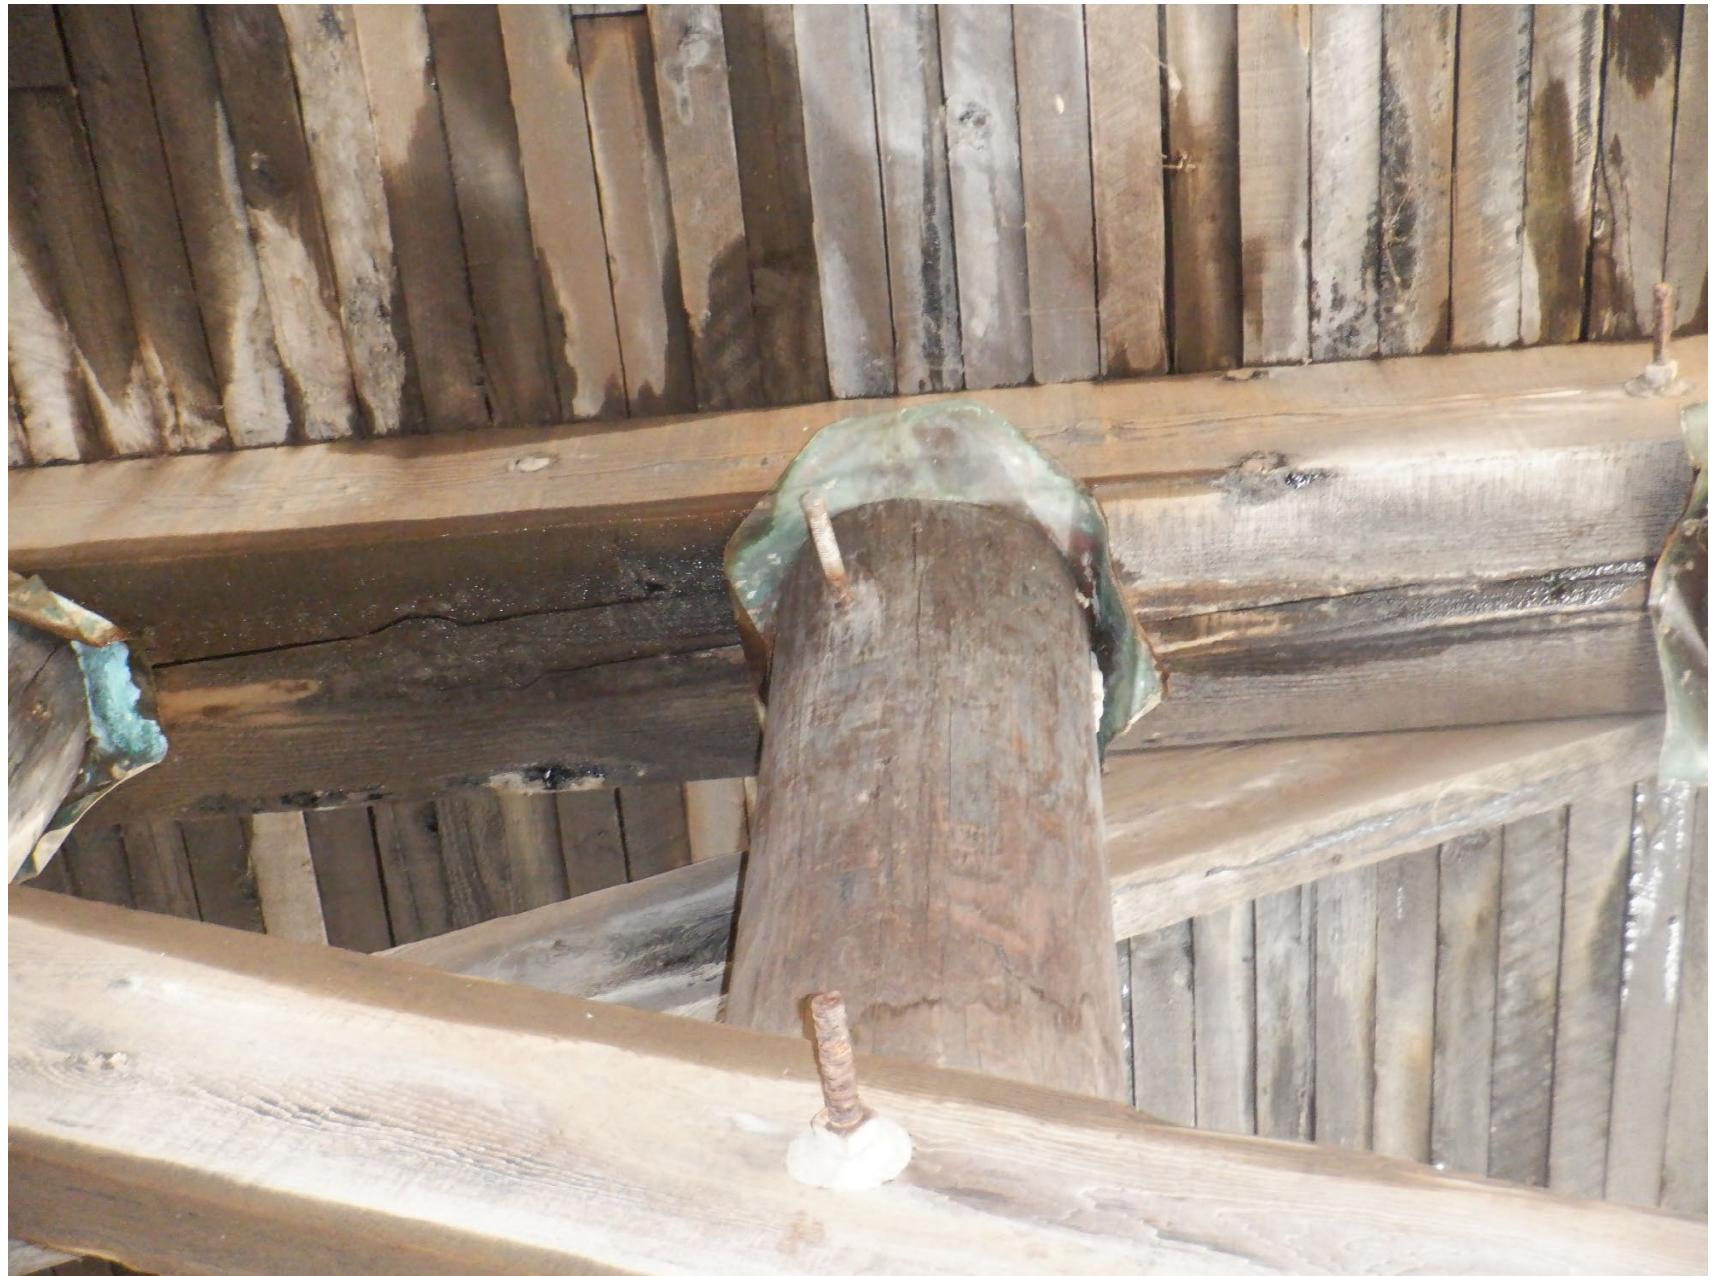
CHECKING WITH LEAKAGE ALONG BOTTOM OF WEST PIER CAP

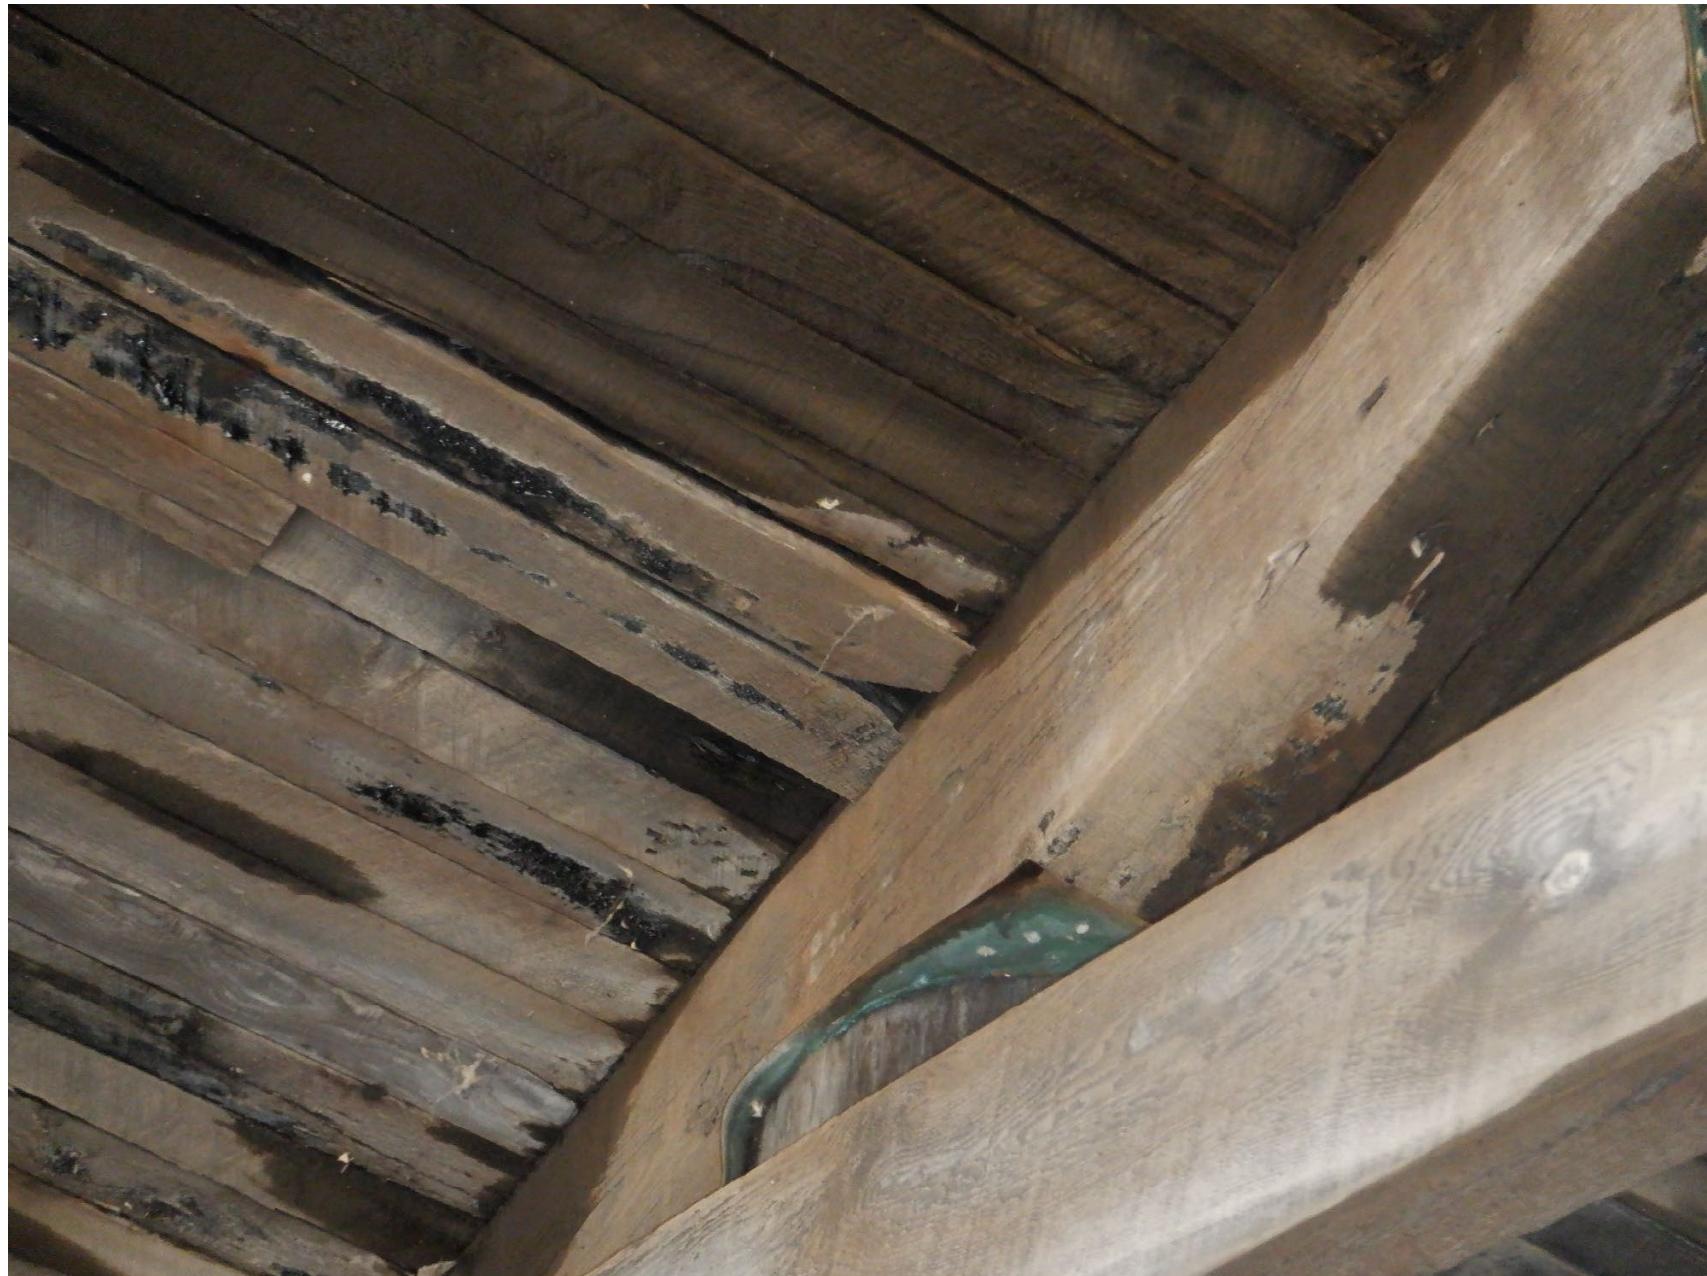
7. Deck (SIA-58)	4	4	4 Cracked/settled HMA along centerline could indicate rot in top of deck boards. 6 cracked deck boards in west span, 6 in center span, 5 in east span. Deck leaks. Loss of creosote treatment away from fascias. (04/25) Cracked/settled HMA along centerline could indicate rot in top of deck boards. 5 cracked deck boards in west span, 5 in center span, 4 in east span. Deck leaks. Loss of creosote treatment away from fascias. (04/24) 5 cracked deck boards in west span, 5 in center span, 4 in east span. Deck leaks. Loss of creosote treatment away from fascias. (04/23)

BROKEN DECK BOARDS ON WEST SIDE OF WEST PIER NEAR CENTERLINE

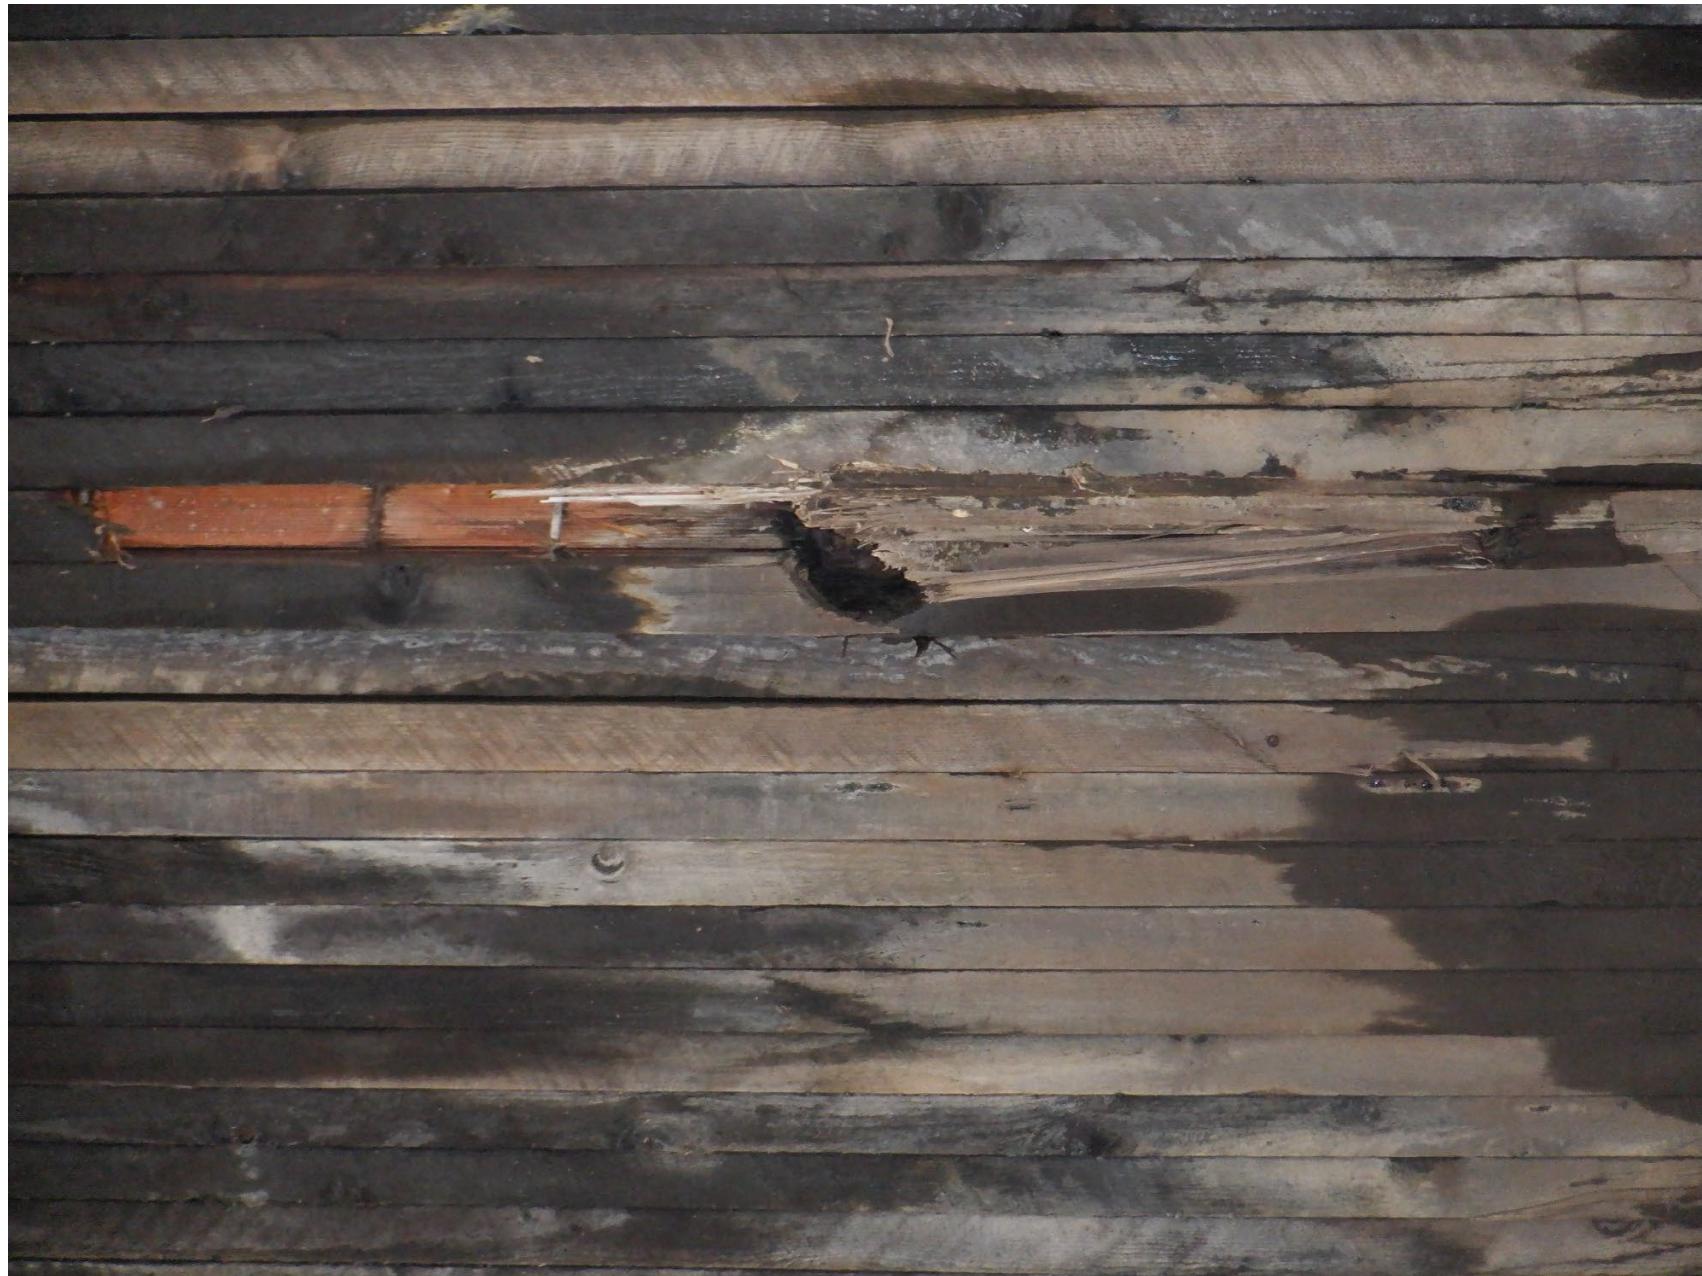
DECK BOARDS DAMAGED FROM SOIL BORING IN CENTER SPAN

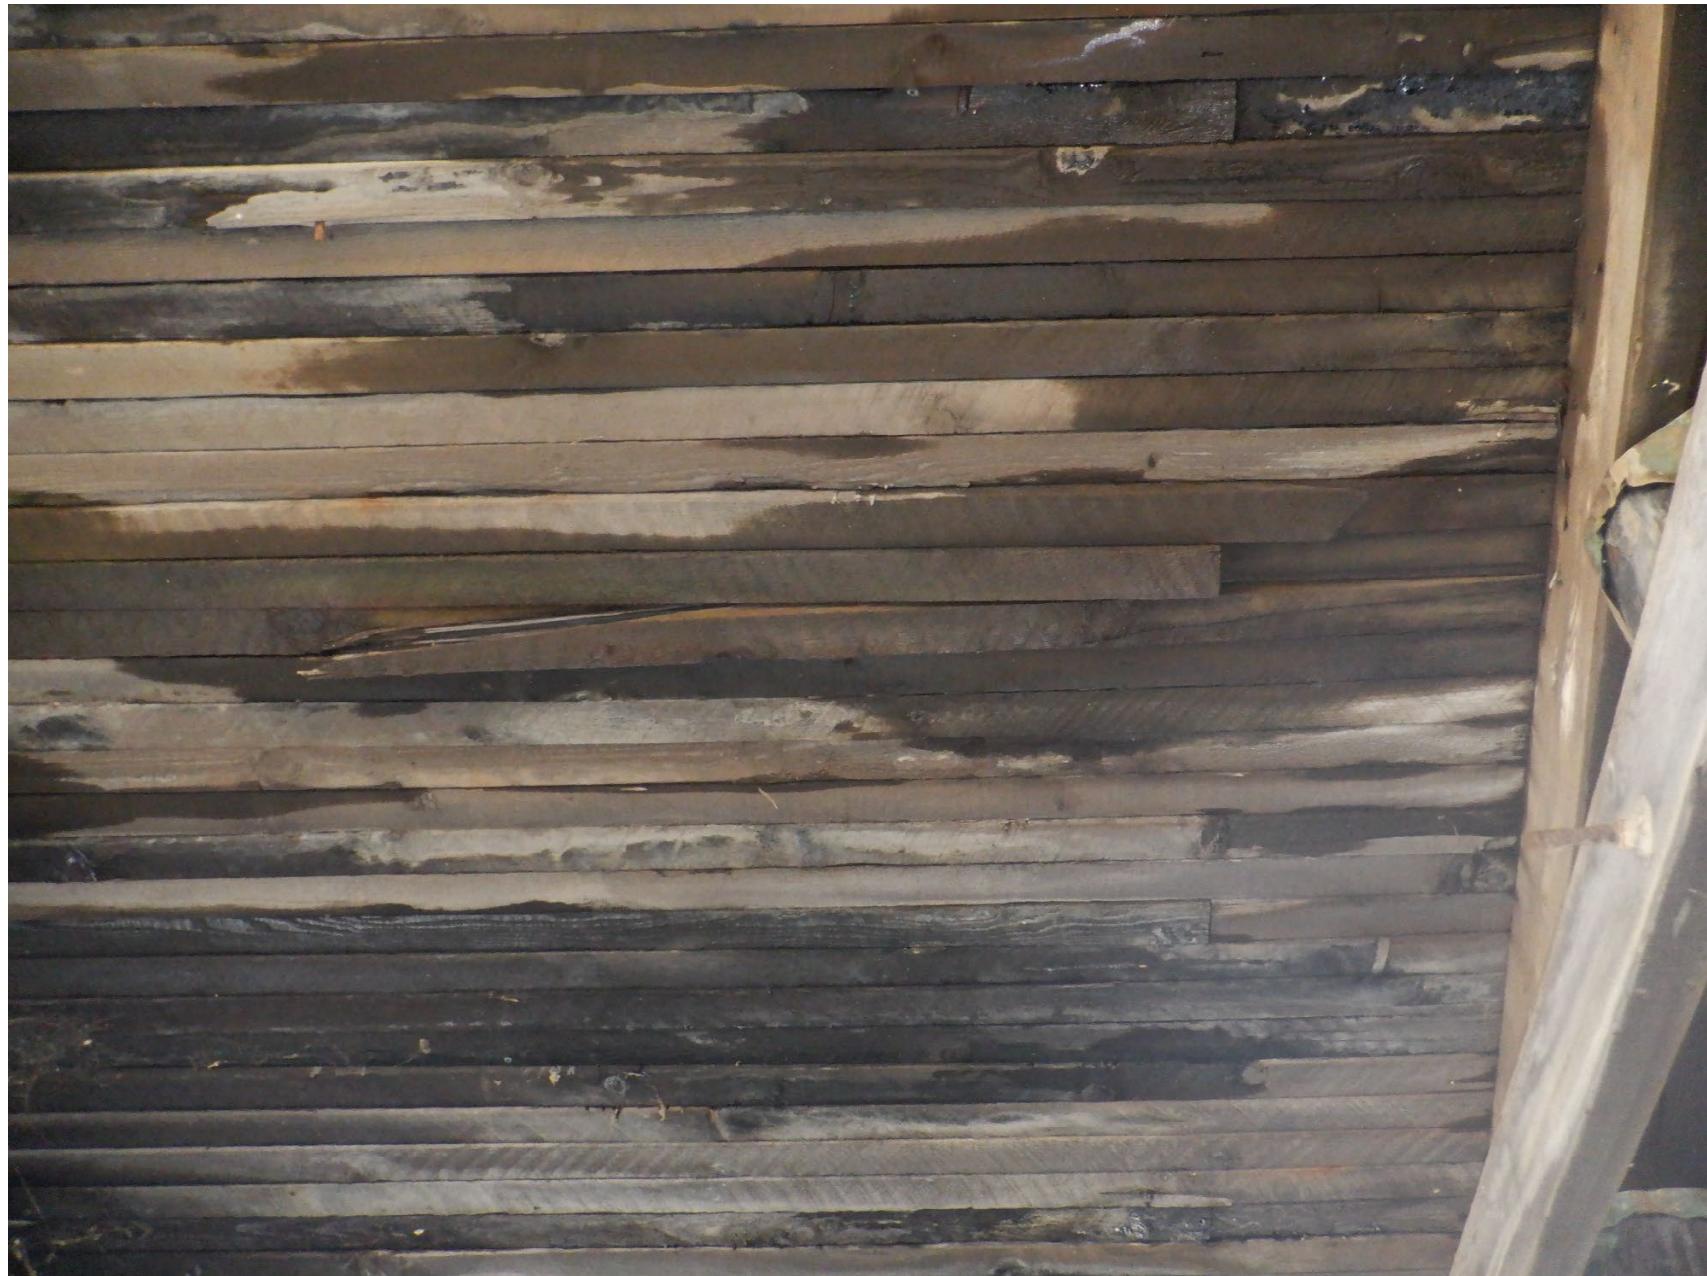
BROKEN DECK BOARDS IN CENTER SPAN NEAR EAST PIER

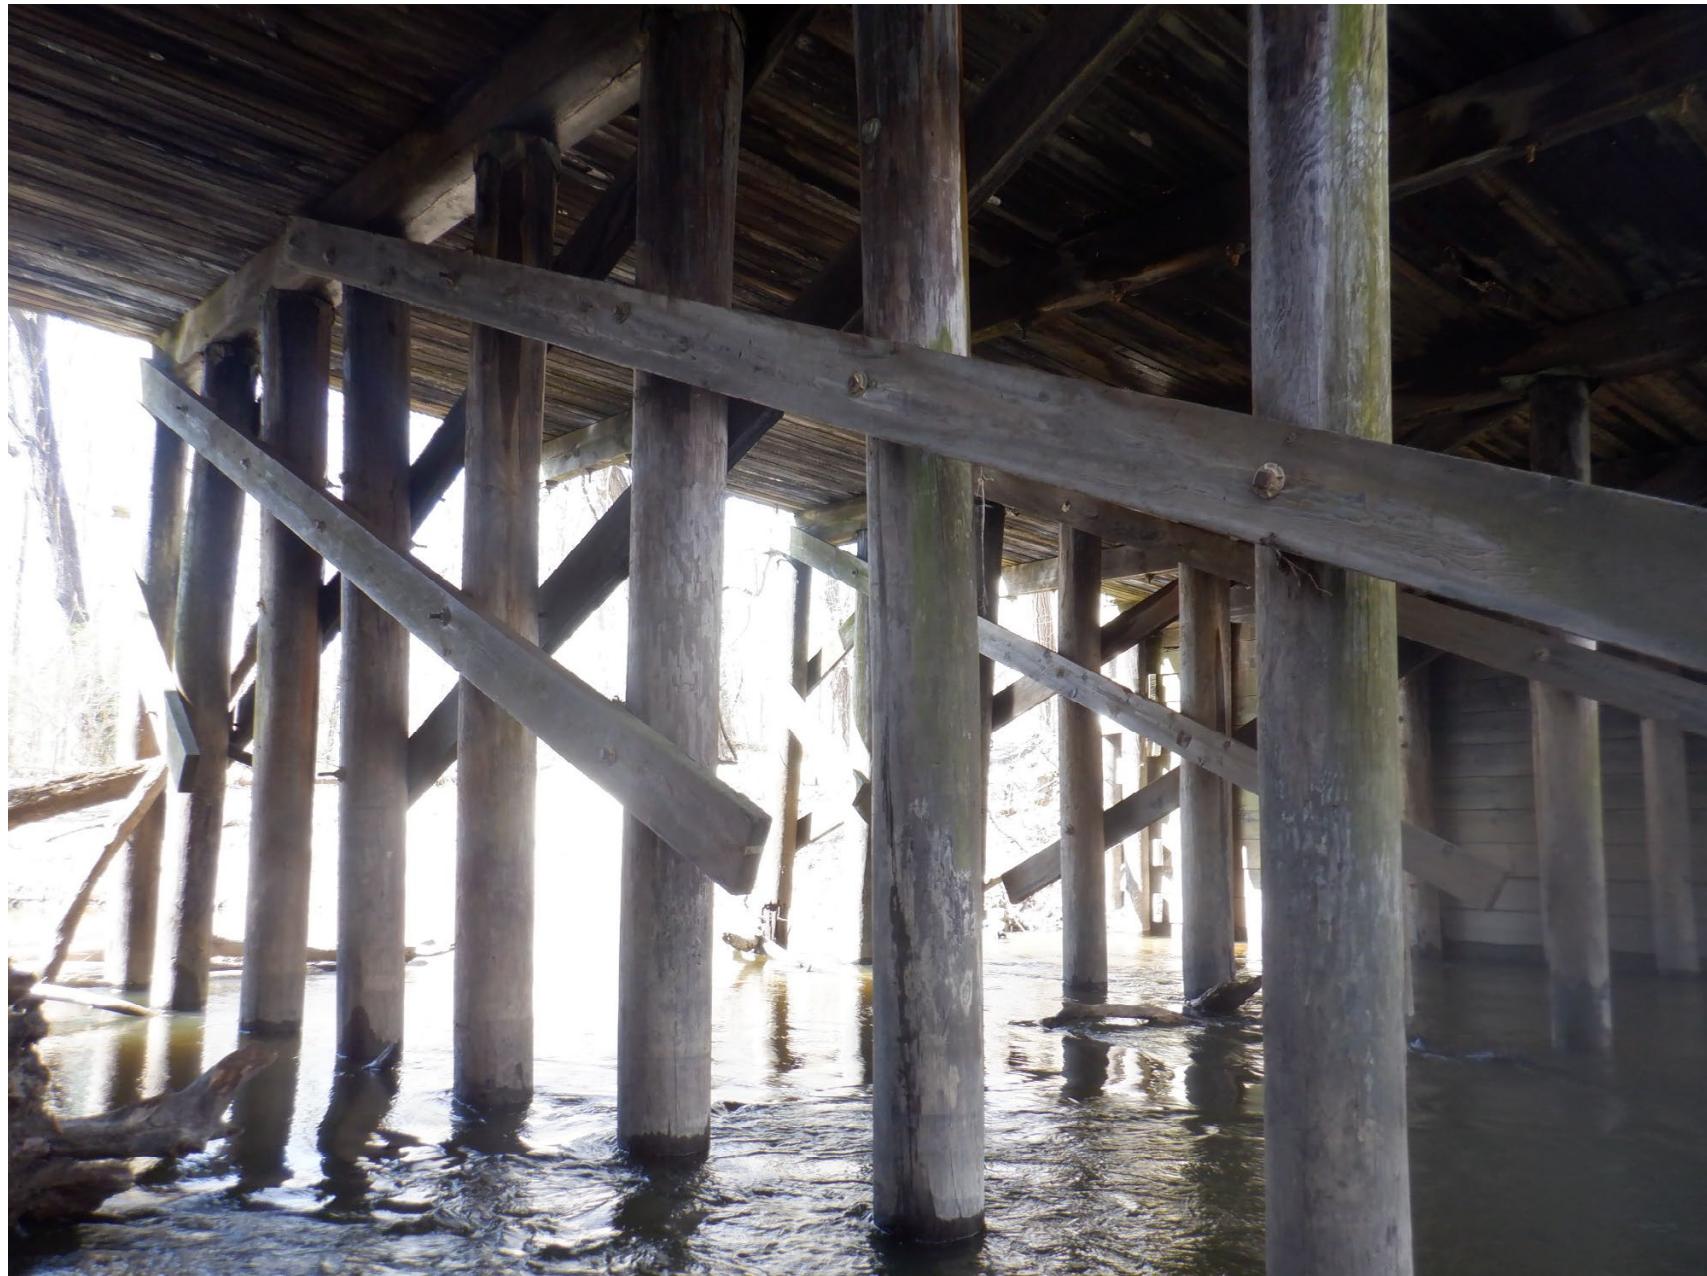
EAST PIER ELEVATION

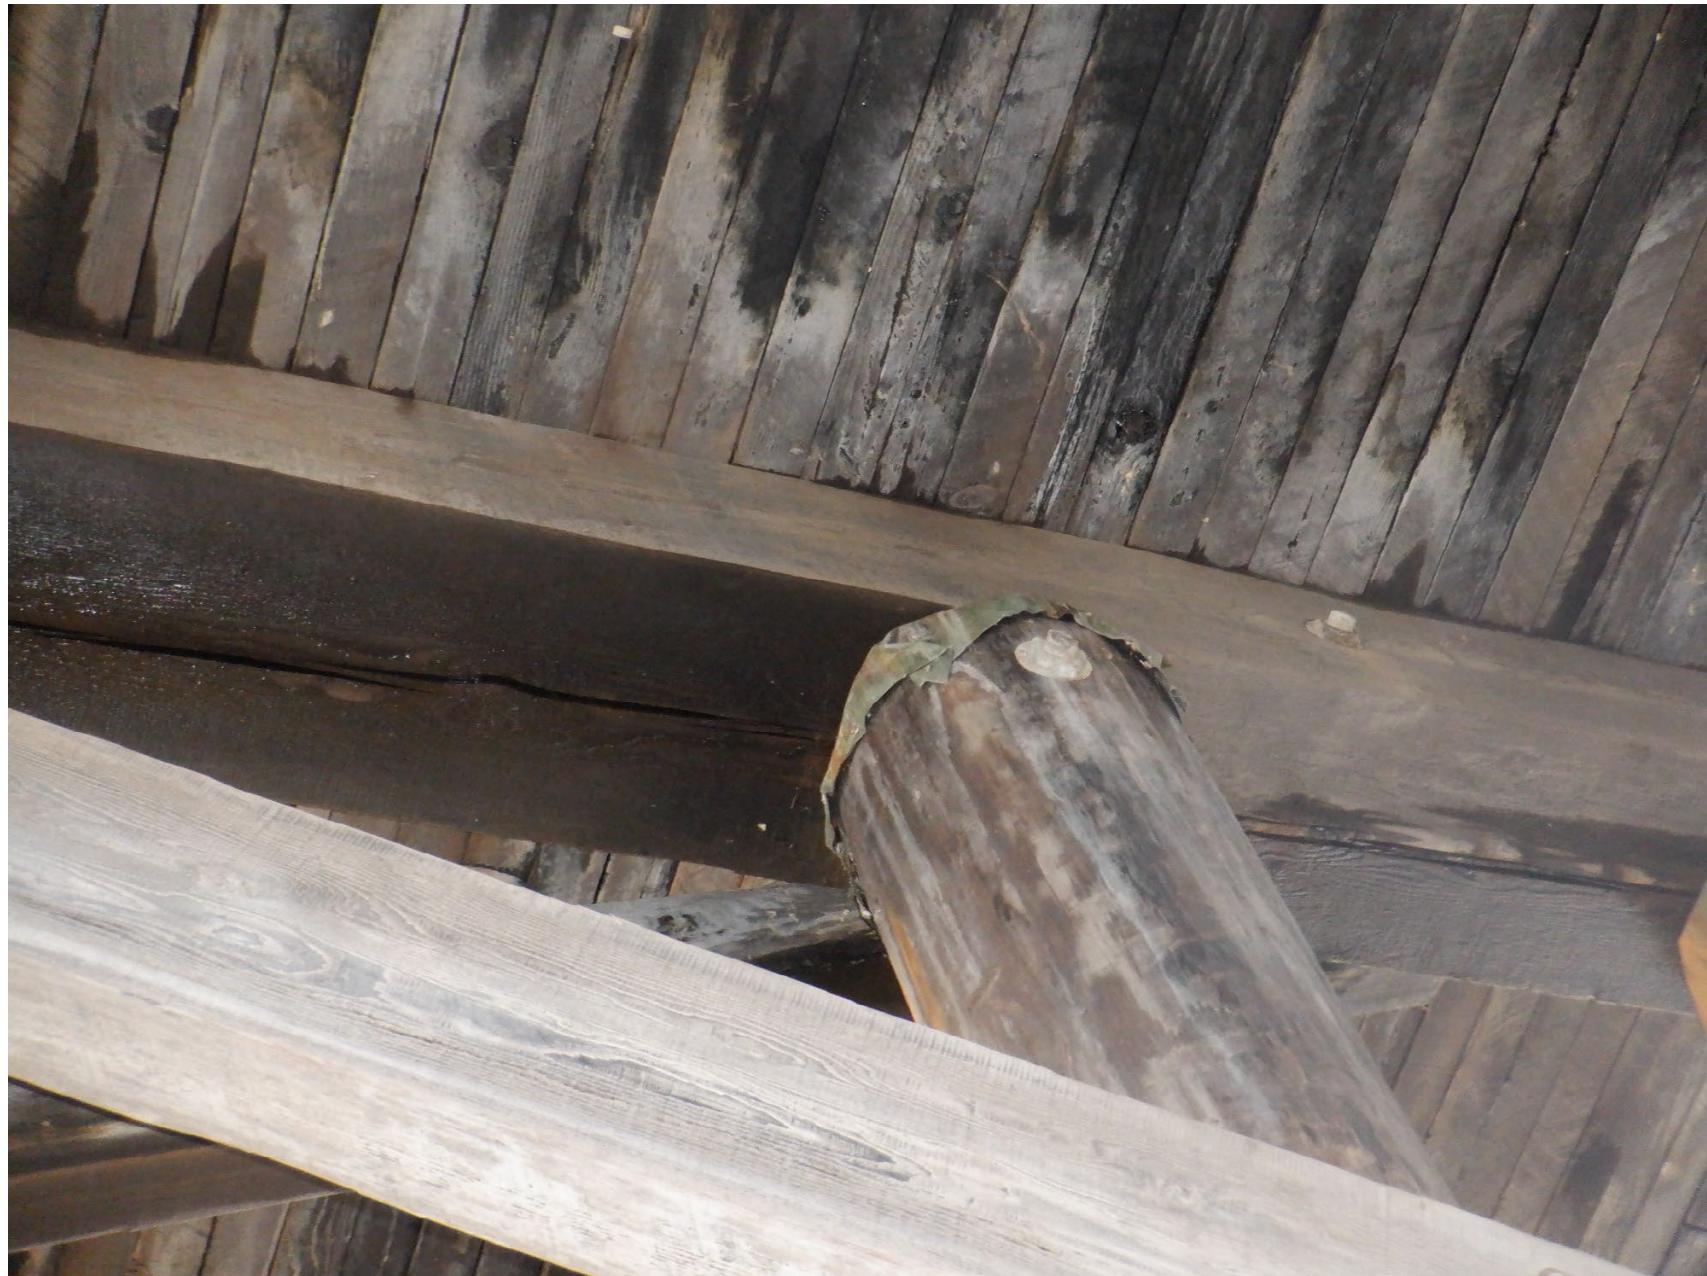
SPLIT WITH LEAKAGE ALONG BOTTOM OF EAST PIER CAP

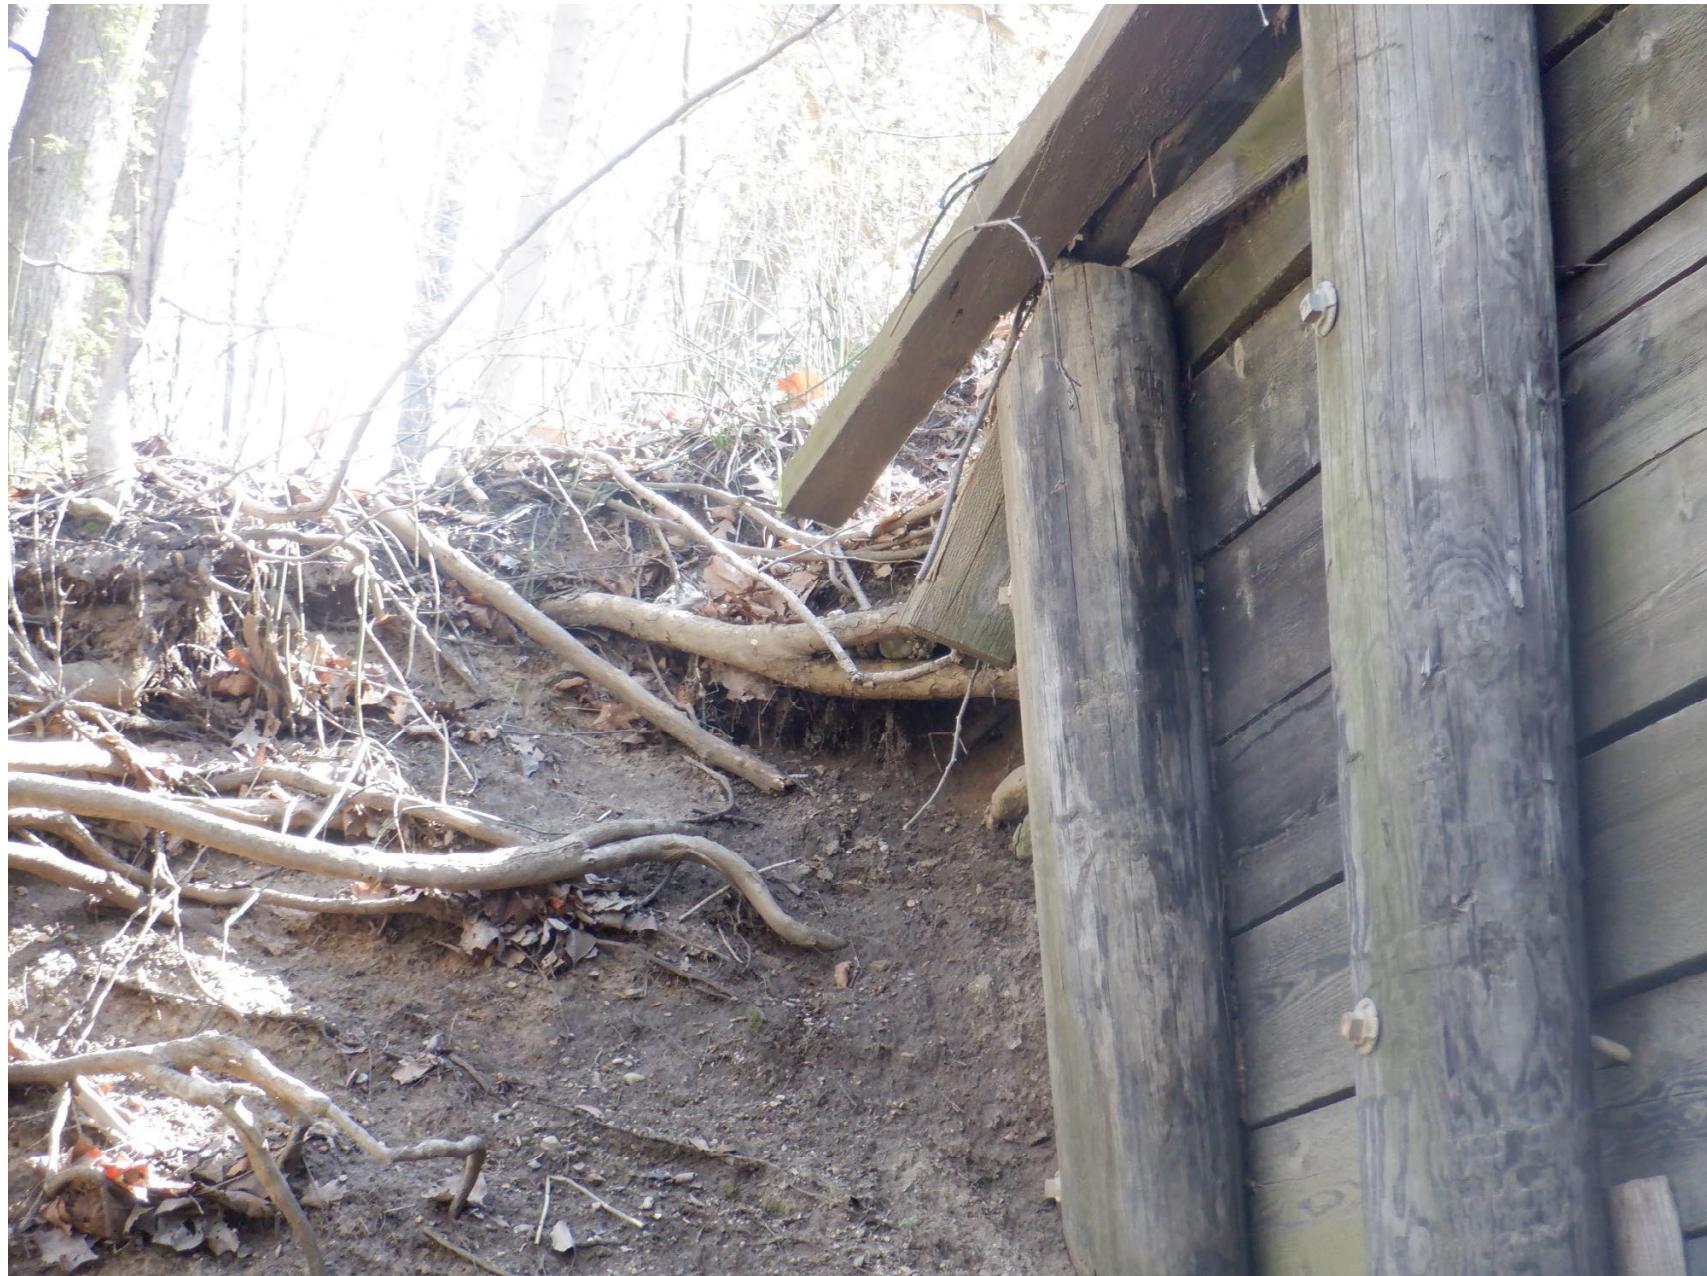
20. Approach Slopes	Steep with no approach guardrail. NE slope is raw at end of wingwall. Erosion in SE slope (slope is very steep) - Riprap in place at structure. (04/25)
	Steep with no approach guardrail. NE slope is raw at end of wingwall. Erosion in SE slope (slope is very steep) - Riprap in place at structure. (04/24)
	Steep with no approach guardrail. NE slope is raw at end of wingwall. Erosion in SE slope (slope is very steep) - Riprap in place at structure. (04/23)
21. Utilities	None on bridge. (04/25)
	None on bridge. (04/24)
	In stream north of structure. (04/23)
22. Drainage Culverts	None noted. (04/25)
	None noted. (04/24)
	None noted. (04/23)

RAW SLOPE IN NORTHEAST QUAD, END OF WINGWALL CAP SPLIT

Recommendation Type	Priority	Description
Slope Repair	L	Add riprap in NE and SE quad.
Remove Debris	M	Remove tree debris from channel.
Railing Repair	H	Replace south bridge rail. Install approach guardrail.
HMA Overlay	M	Remove and resurface HMA over bridge, add waterproofing membrane. Check top of deck condition.
Bridge Repl.	H	Budget for replacement.

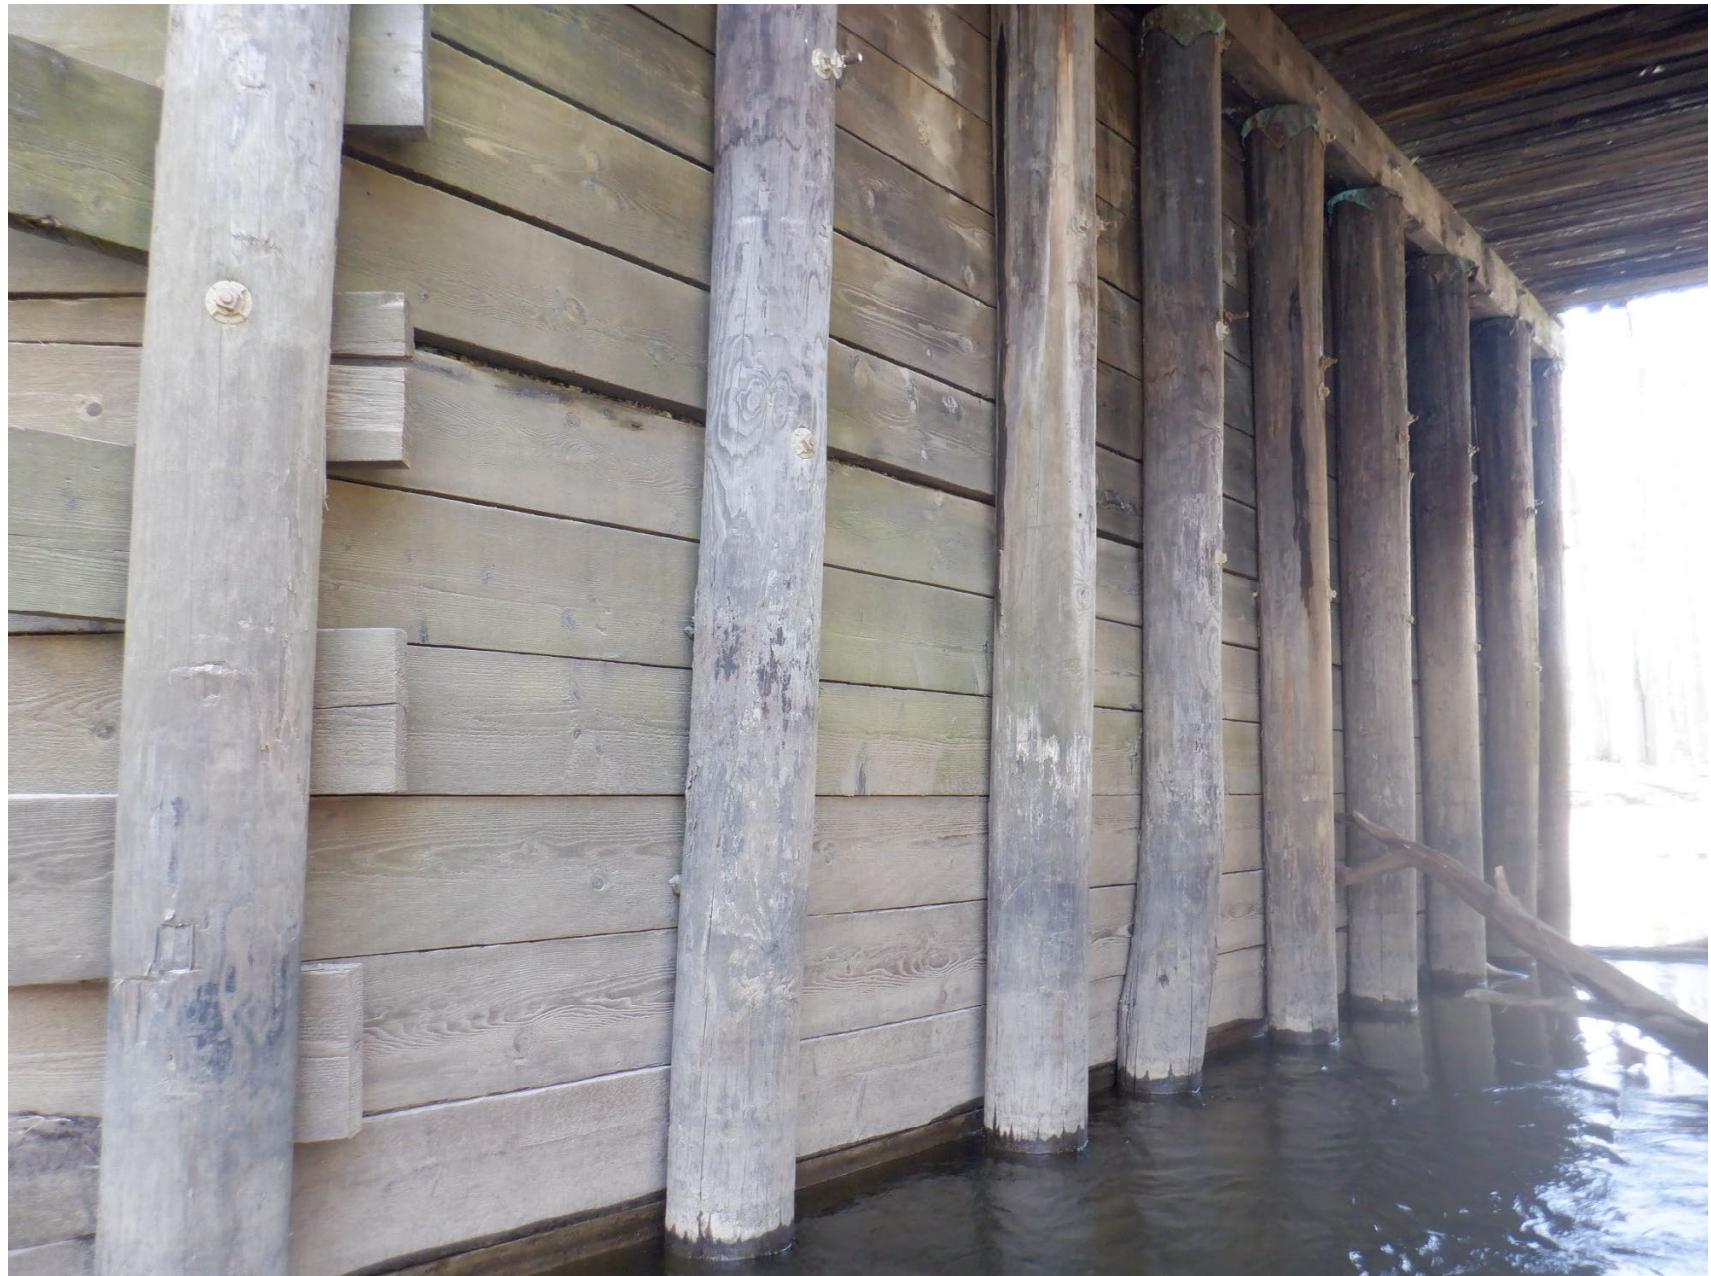
EAST ABUTMENT ELEVATION

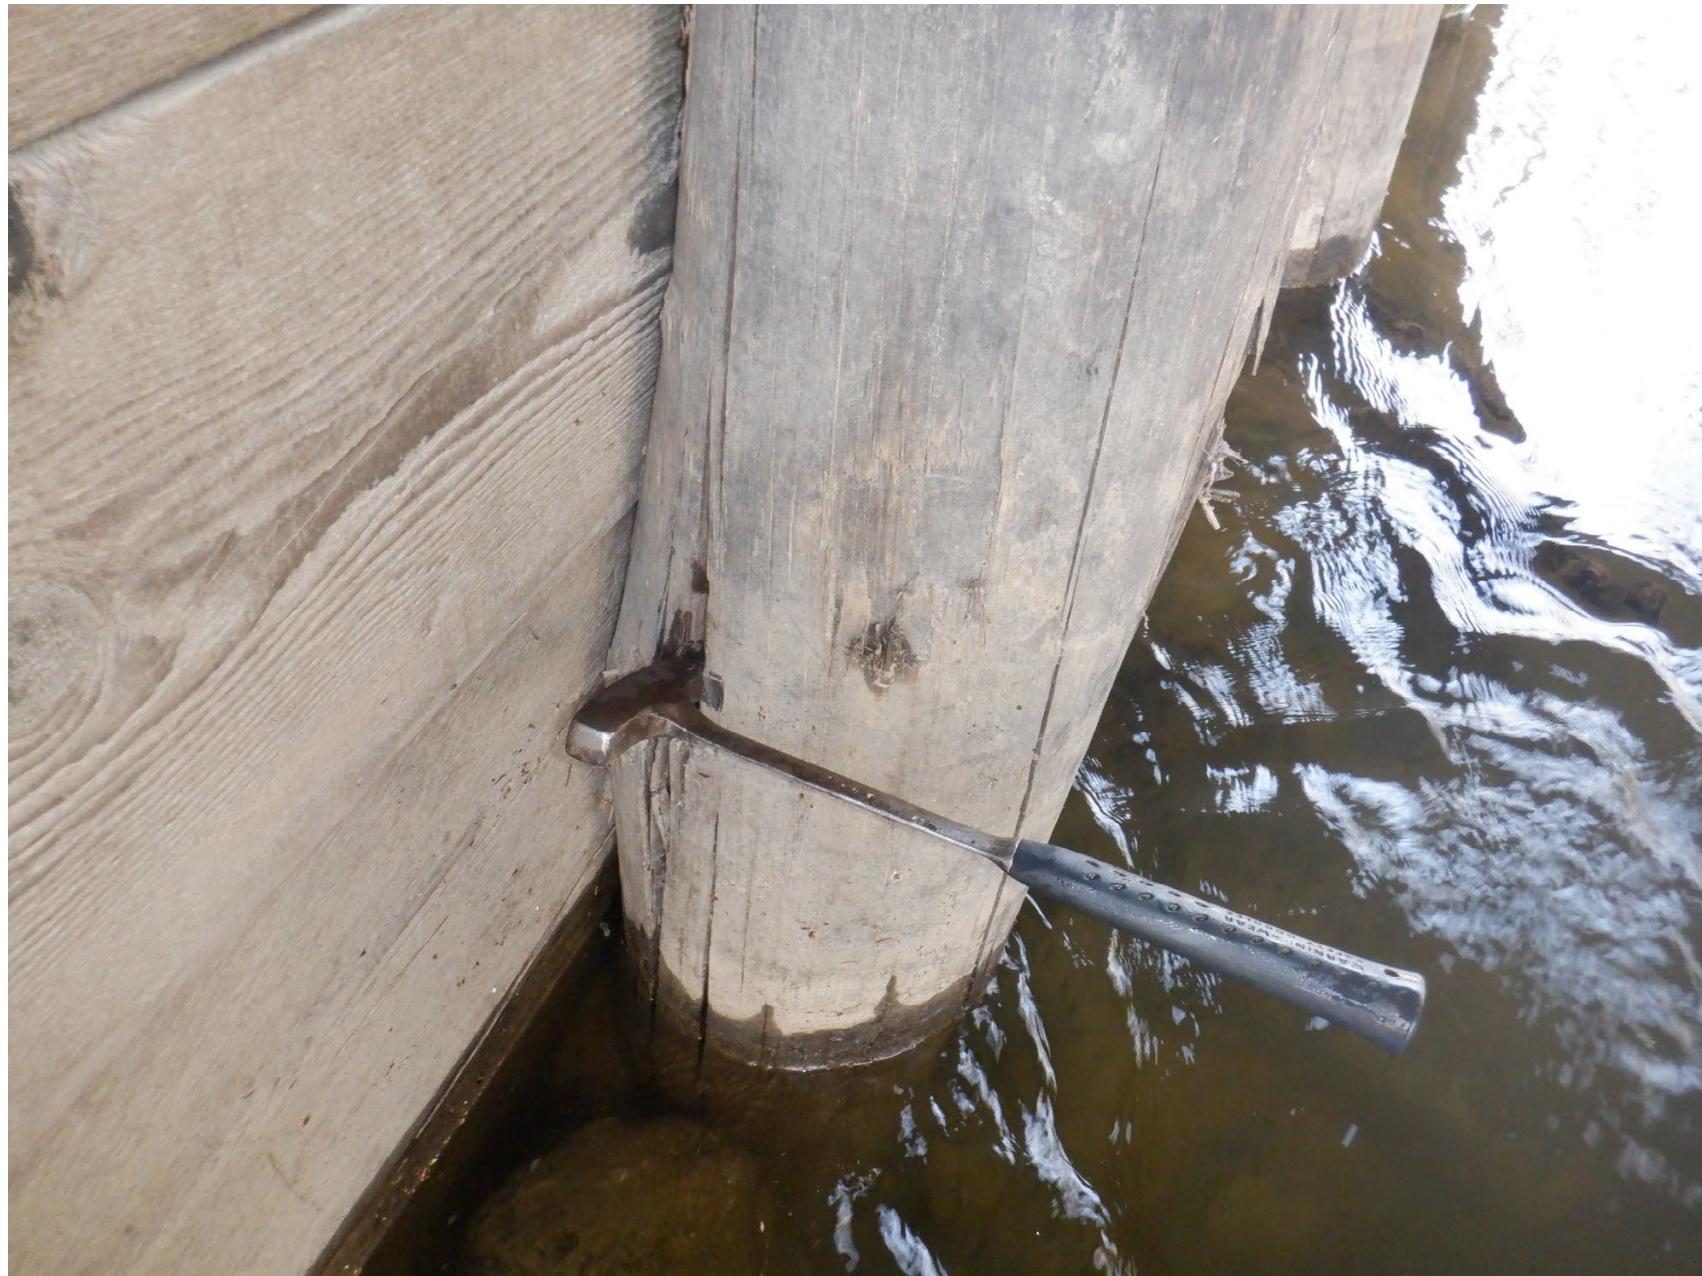
EAST ABUTMENT PILE 4N ROTTING ON BACKSIDE NEAR WATERLINE

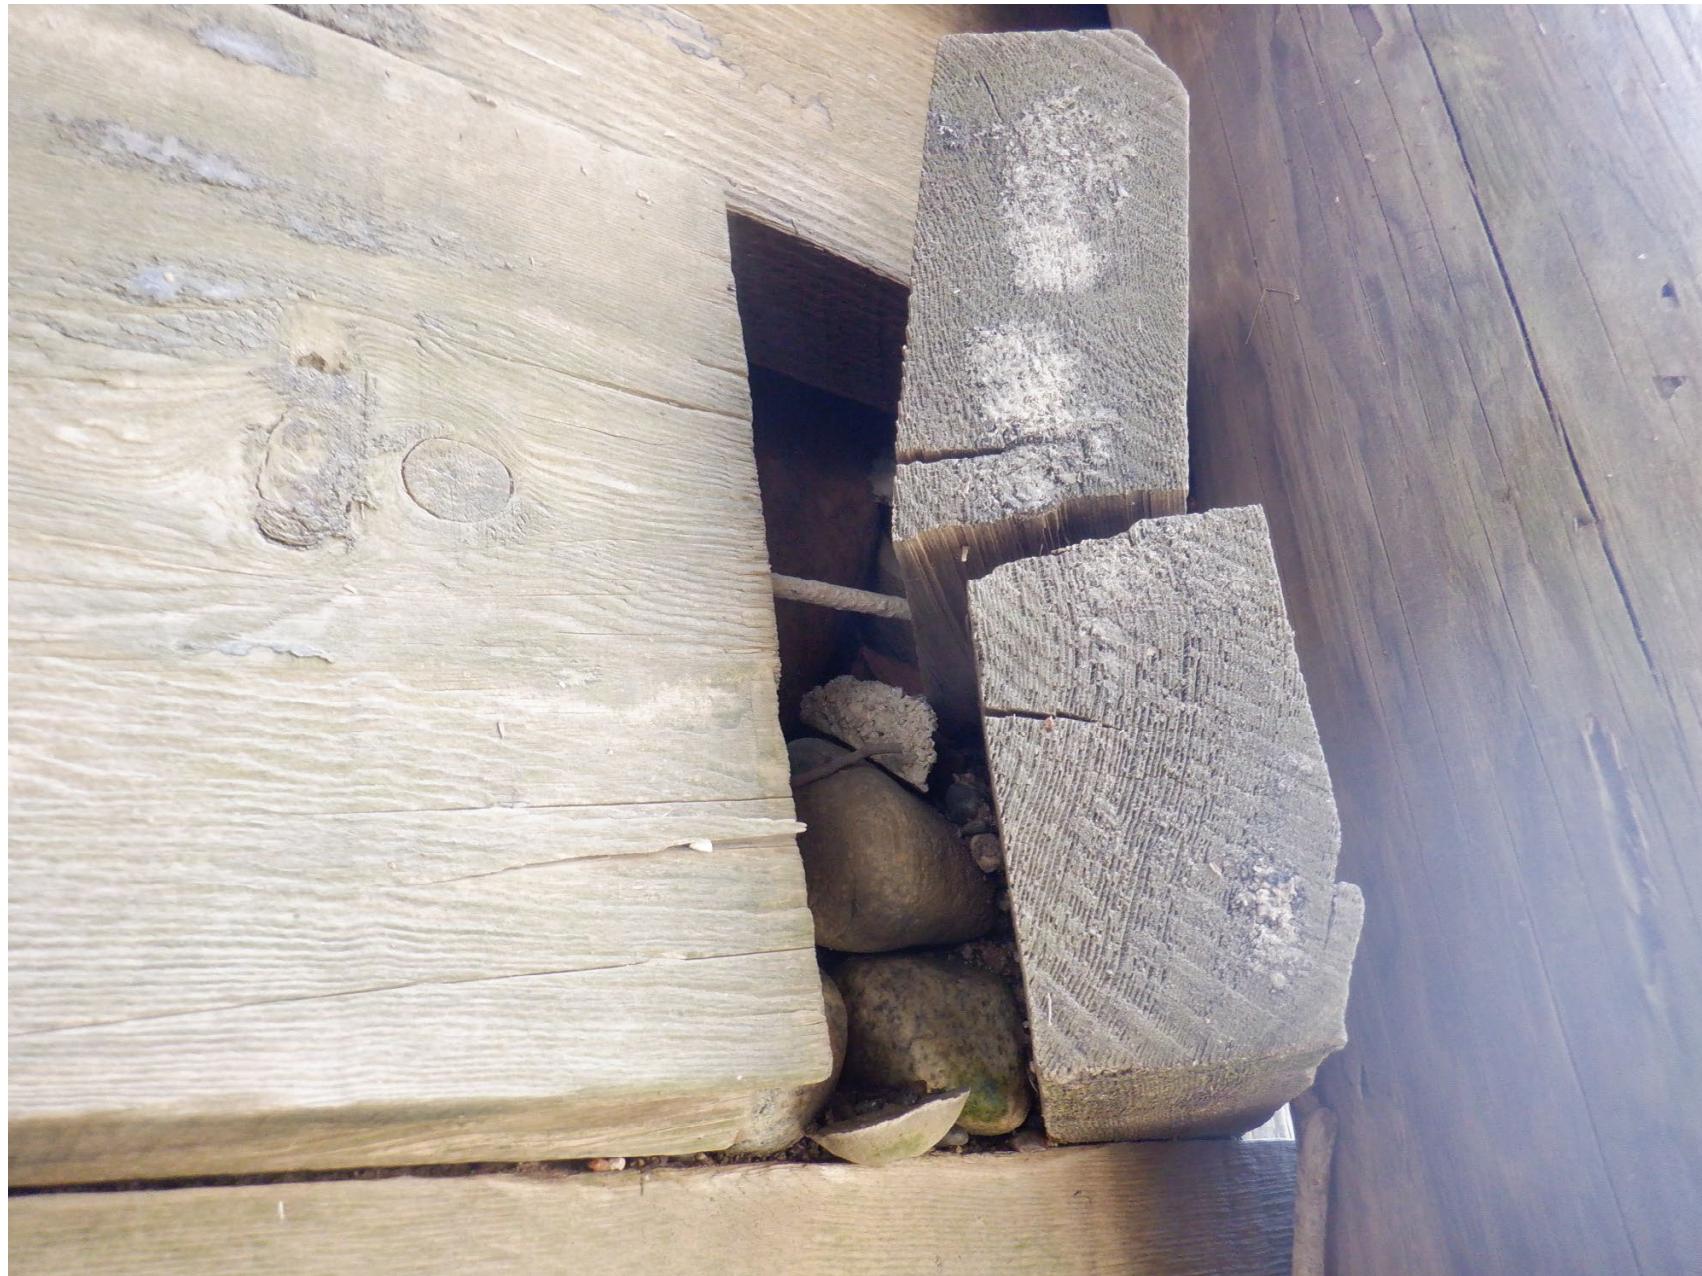
GAP IN BACKWALL BOARDS AT SOUTHEAST ABUTMENT CORNER
